# Karachi effects of the Makran earthquake and tsunami of November 1945

**Mercury spilled, tide gauge impaired, seawalls overrun, boats displaced, mosque flooded**

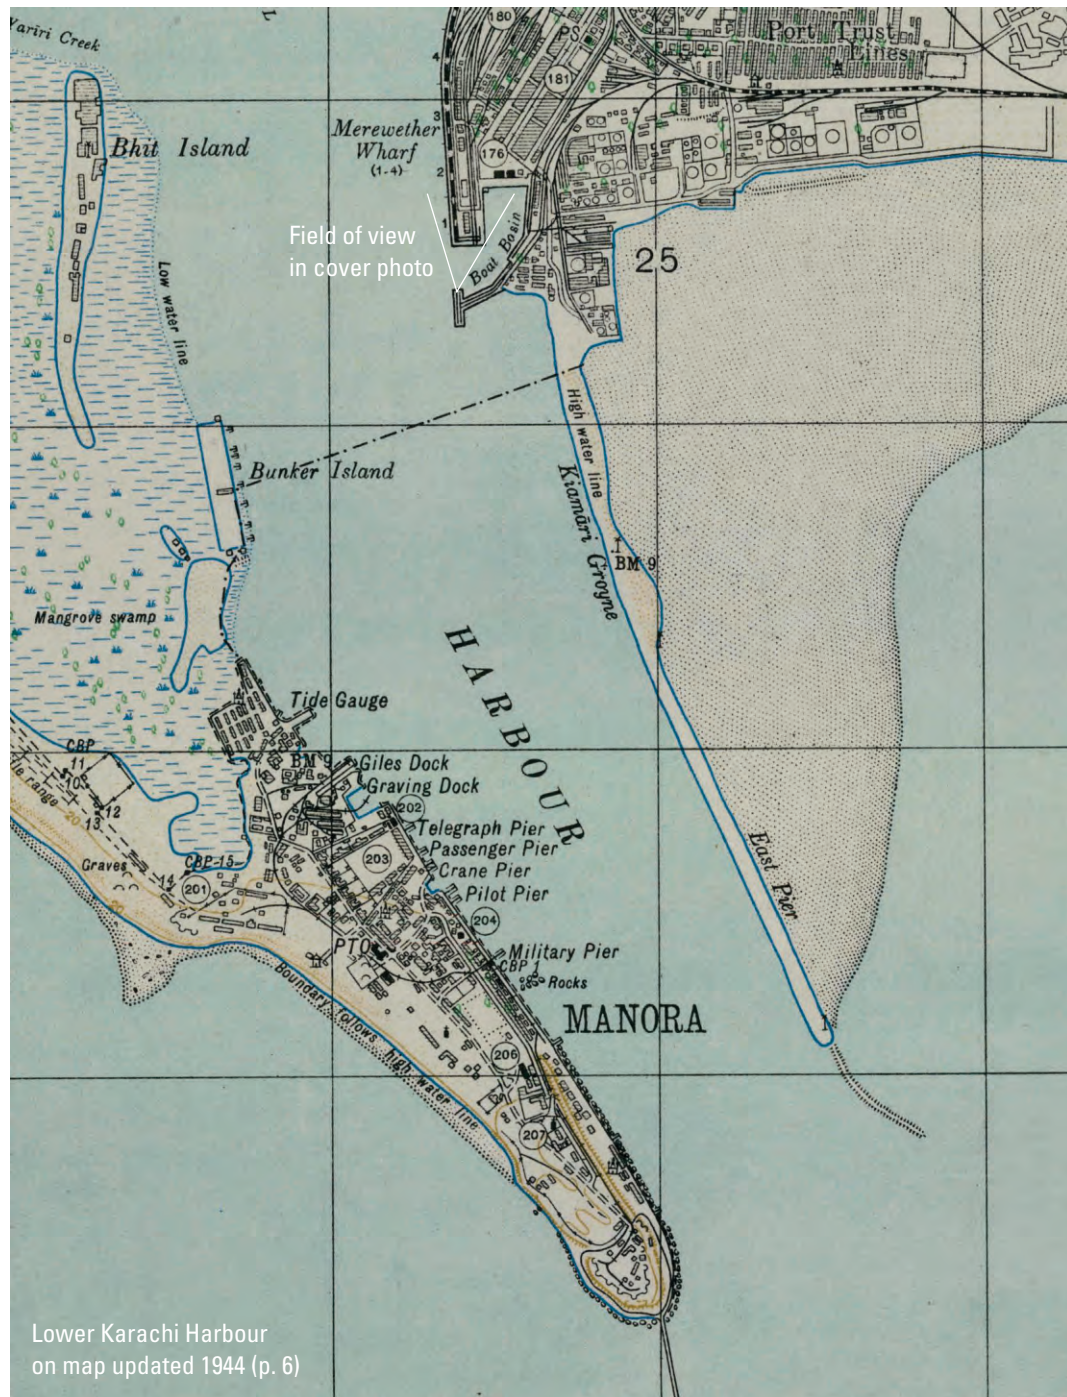
Lower Karachi Harbour  
on map updated 1944 (p. 6)

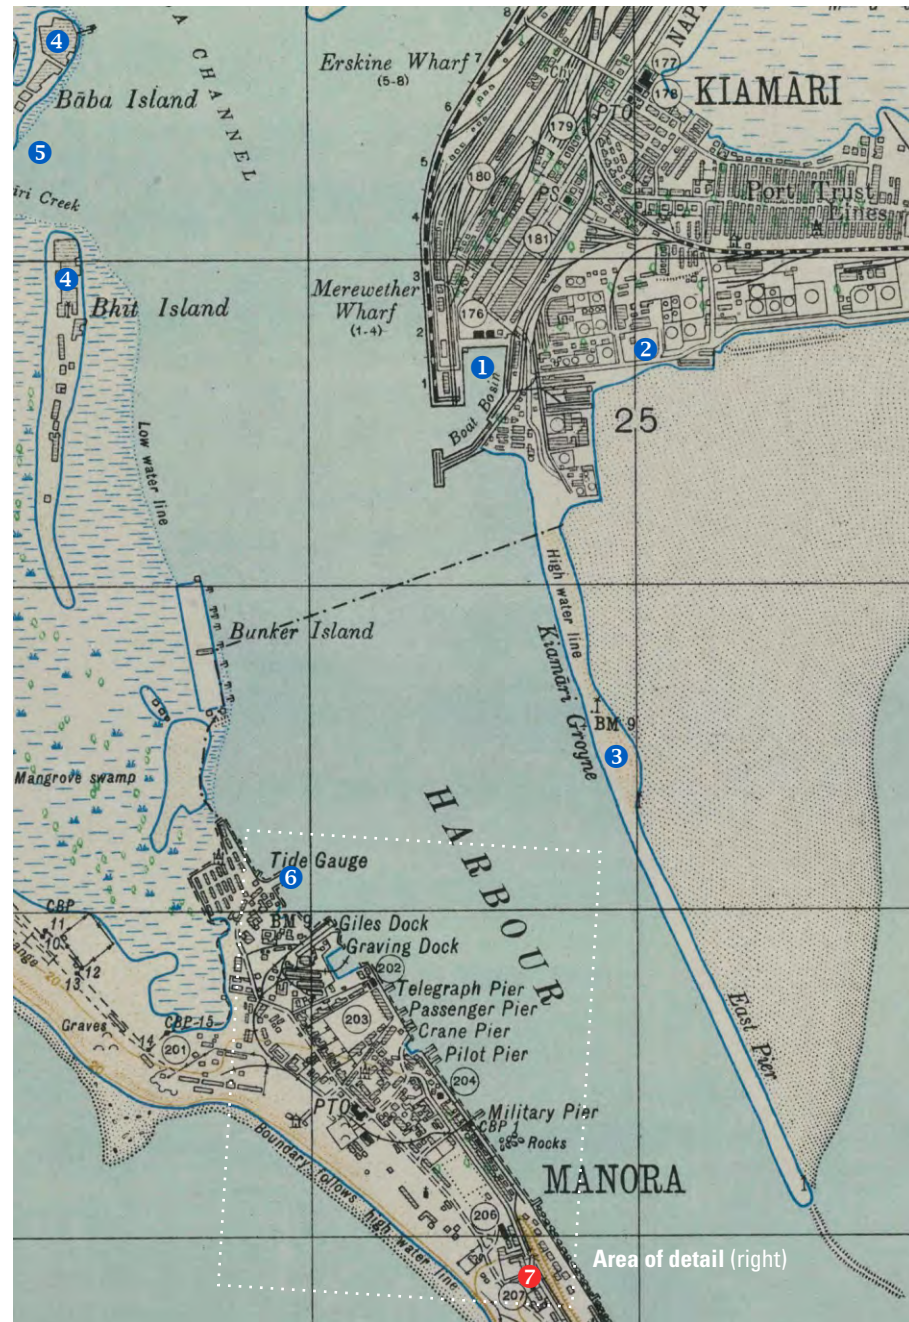
## Geographic index to earthquake ● and tsunami ● effects

### Keamari (Kiamari) and vicinity

- 1 Boat Basin—Landing craft stranded atop wharves, according to testimony in 2018 (p. 26–28).
- 2 Oil installations—Facilities flooded, according to contemporary newspapers. Site or sites of flooding not identified but probably among tanks (circles) between Boat Basin and east edge of map (p. 22–23).
- 3 Keamari Groyne—120 m of rock wall damaged, according to two contemporary newspapers. Neither pinpointed the damage but one noted loss of a beacon on the groyne. A third paper told of apparent overtopping on a northern part of the groyne (p. 21, 24).

THE MAP, brightened for added labels, contains parts of two Survey of India One-Inch Sheets: 35 L/13, 3rd ed., 1945, and 35 P/1, 4th ed., 1944. Both were initially surveyed 1925–1926. Purple grid 0.914 km.

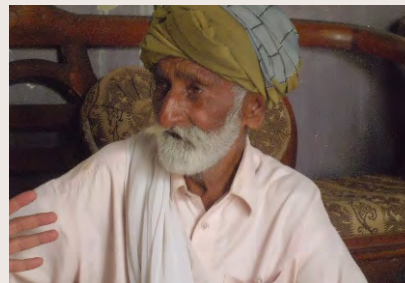
Shaking in **Pasni** caused land to sink and crack.

Ground cracks in Pasni were recalled by three persons interviewed in 2014. Mr. Dost stated that ground split open and blood-red water came out of the cracks. Karīm Buksh reported observing these effects in Wadsar.

These effects imply that shaken sand lost strength and expelled water by liquefaction. Liquefied sand beneath Wadsar probably enabled the neighborhood to slide into the sea.

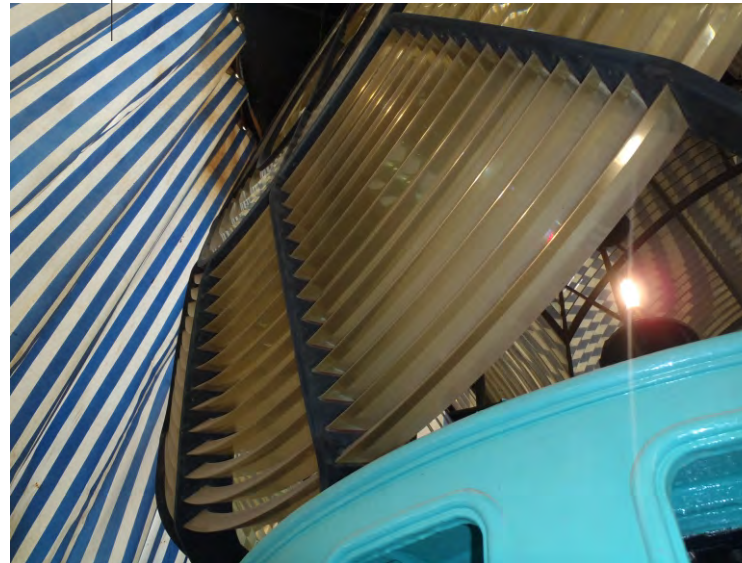
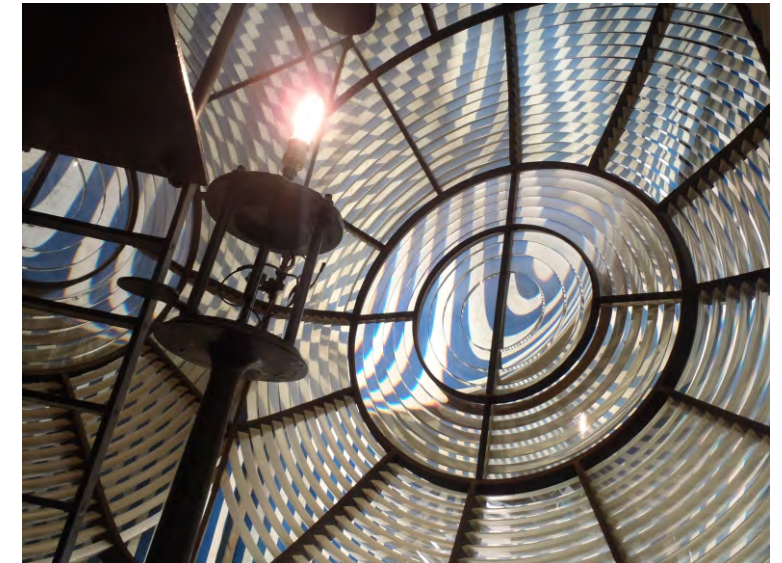
**Frequent flashes**

With its four-panel assembly completing two revolutions per minute, the Manora hyper-radial can produce a flash in any given direction every eighth of a minute. This is the interval of 7.5 seconds advertised on Admiralty chart 40 (below) and called “the correct time” in a logbook entry from October 6, 1945 (p. 12).

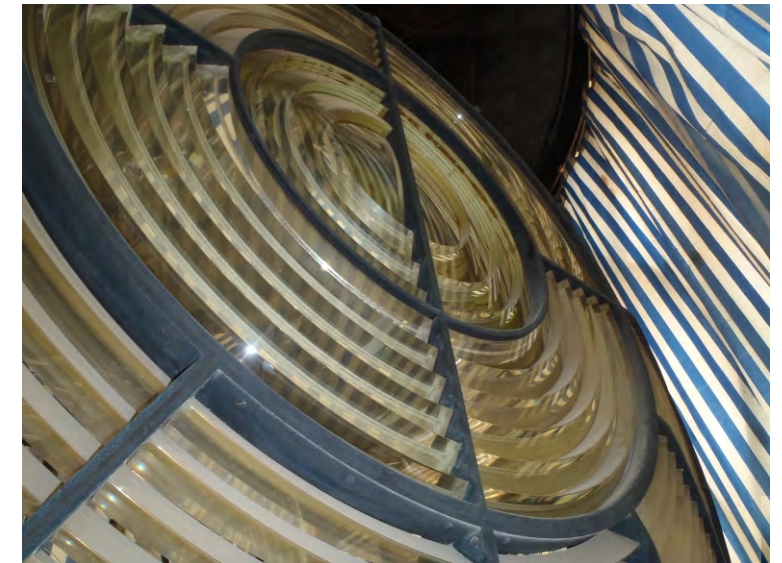
The assembly of four **lens panels** is supported by, and turns with, a **revolving ring** (turquoise). The revolutions are guided by rollers. The revolving ring rests on an annular float that is immersed in mercury (p. 8, 10). Parts of all four panels are visible in the lower left image.

This mathematical proposition of Archimedes, applied in the Manora hyper-radial, enables its heavy optical apparatus to revolve in a modest quantity of liquid metal (diagrams, right). The revolving load floats in a mere 25 liters of mercury. “It is possible,” the maker noted in 1910, “to revolve an apparatus weighing several tons, if it is supported in this way, with the little finger only.”

The mercury spilled during the 1945 earthquake—a little over one liter—may have used a path that this easy rotation requires. A narrow clearance prevents the revolving ring from rubbing against the fixed trough beneath it. Within this trough is a nested float that supports the revolving load by Archimedian immersion in mercury. Pressed against the trough by earthquake motions, vertical or horizontal, the float may have squeezed the liquid metal through the narrow clearance.

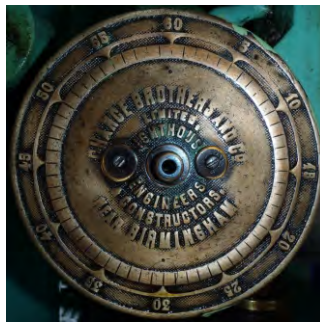
**Maker's insigne**  
 (near winding shaft, right;  
 at level of man's waist, p. 8)

CHANCE BROTHERS AND CO.  
 LIMITED  
 LIGHTHOUSE ENGINEERS  
 & CONSTRUCTORS  
 NEAR BIRMINGHAM

MANUFACTURER'S NOTES in Chance Brothers and Co., Limited (1910, p. 55, 56) are paraphrased and quoted on this page.

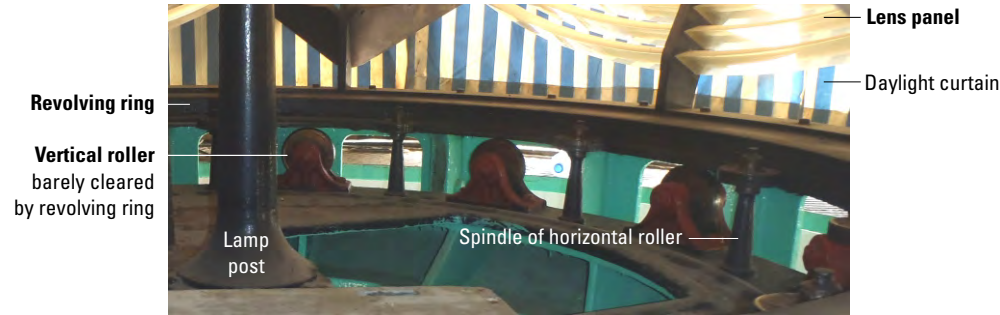
**Stabilizing rollers**

**Revolving ring**  
**Vertical roller** barely cleared by revolving ring  
**Lens panel**  
**Daylight curtain**  
**Lamp post**  
**Spindle of horizontal roller**

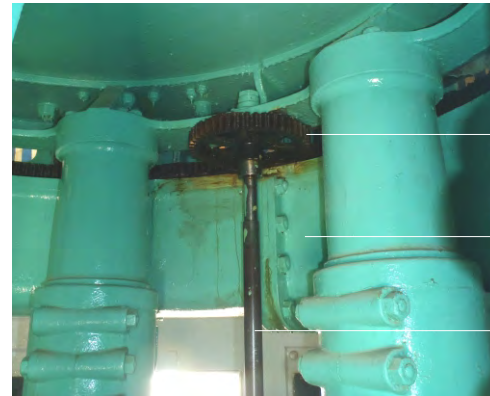
**Pinion** gearing with a “circular rack” on the revolving ring  
**Trough** containing float and mercury  
**Vertical shaft**

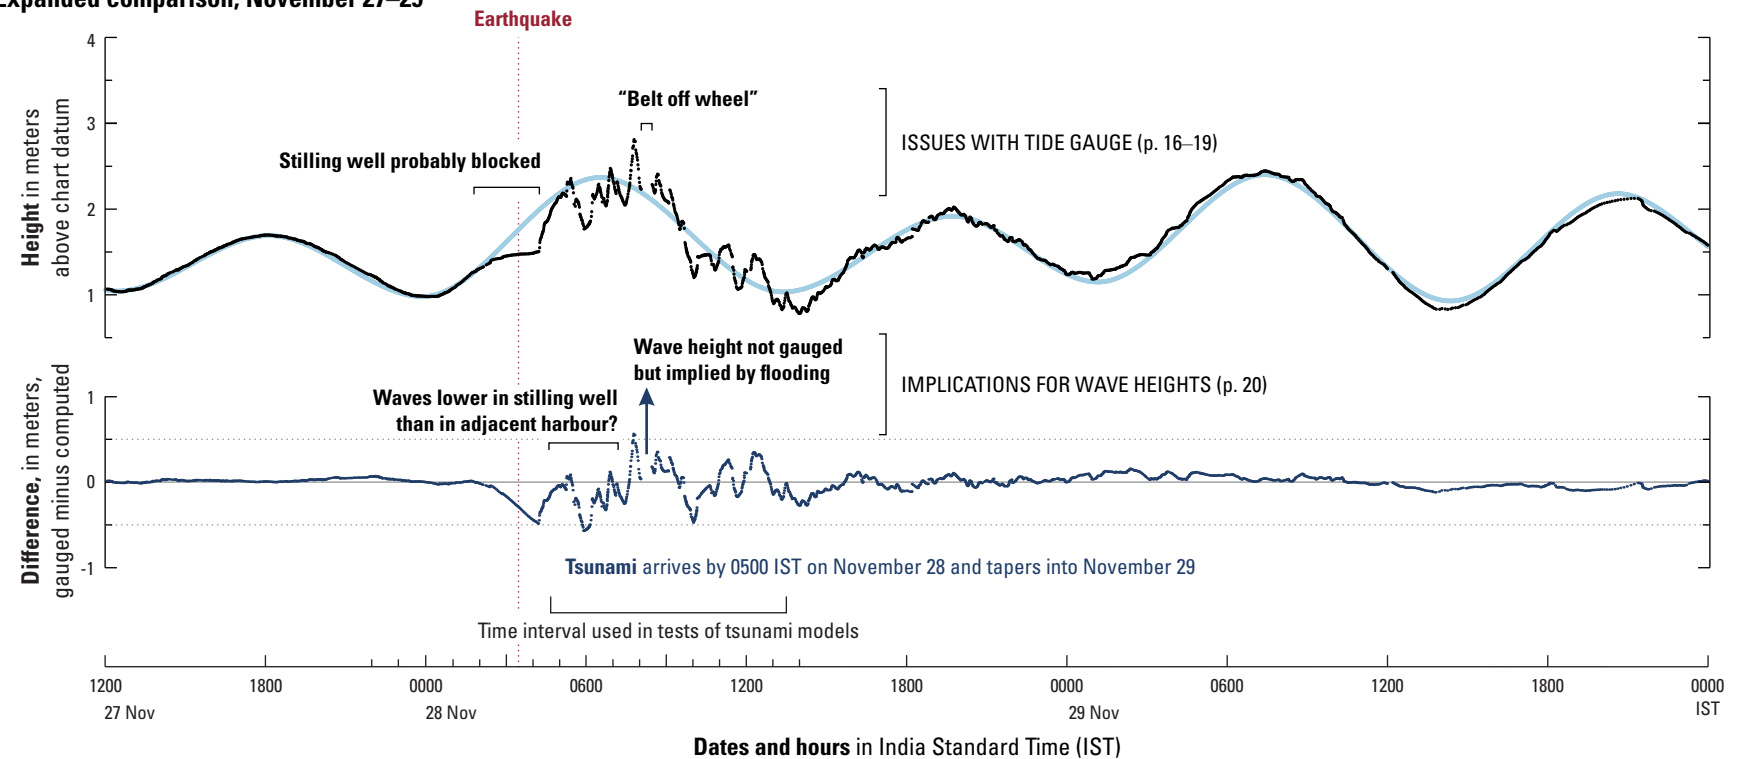
Expanded comparison, November 27–29

Shorter gaps interrupt the record from the day of the earthquake, November 28. The first contains an “out of order” note early in an anomaly that probably resulted from blockage of the stilling well (p. 16–17). Two later gaps were likely caused by the 1945 tsunami itself (p. 18–19).

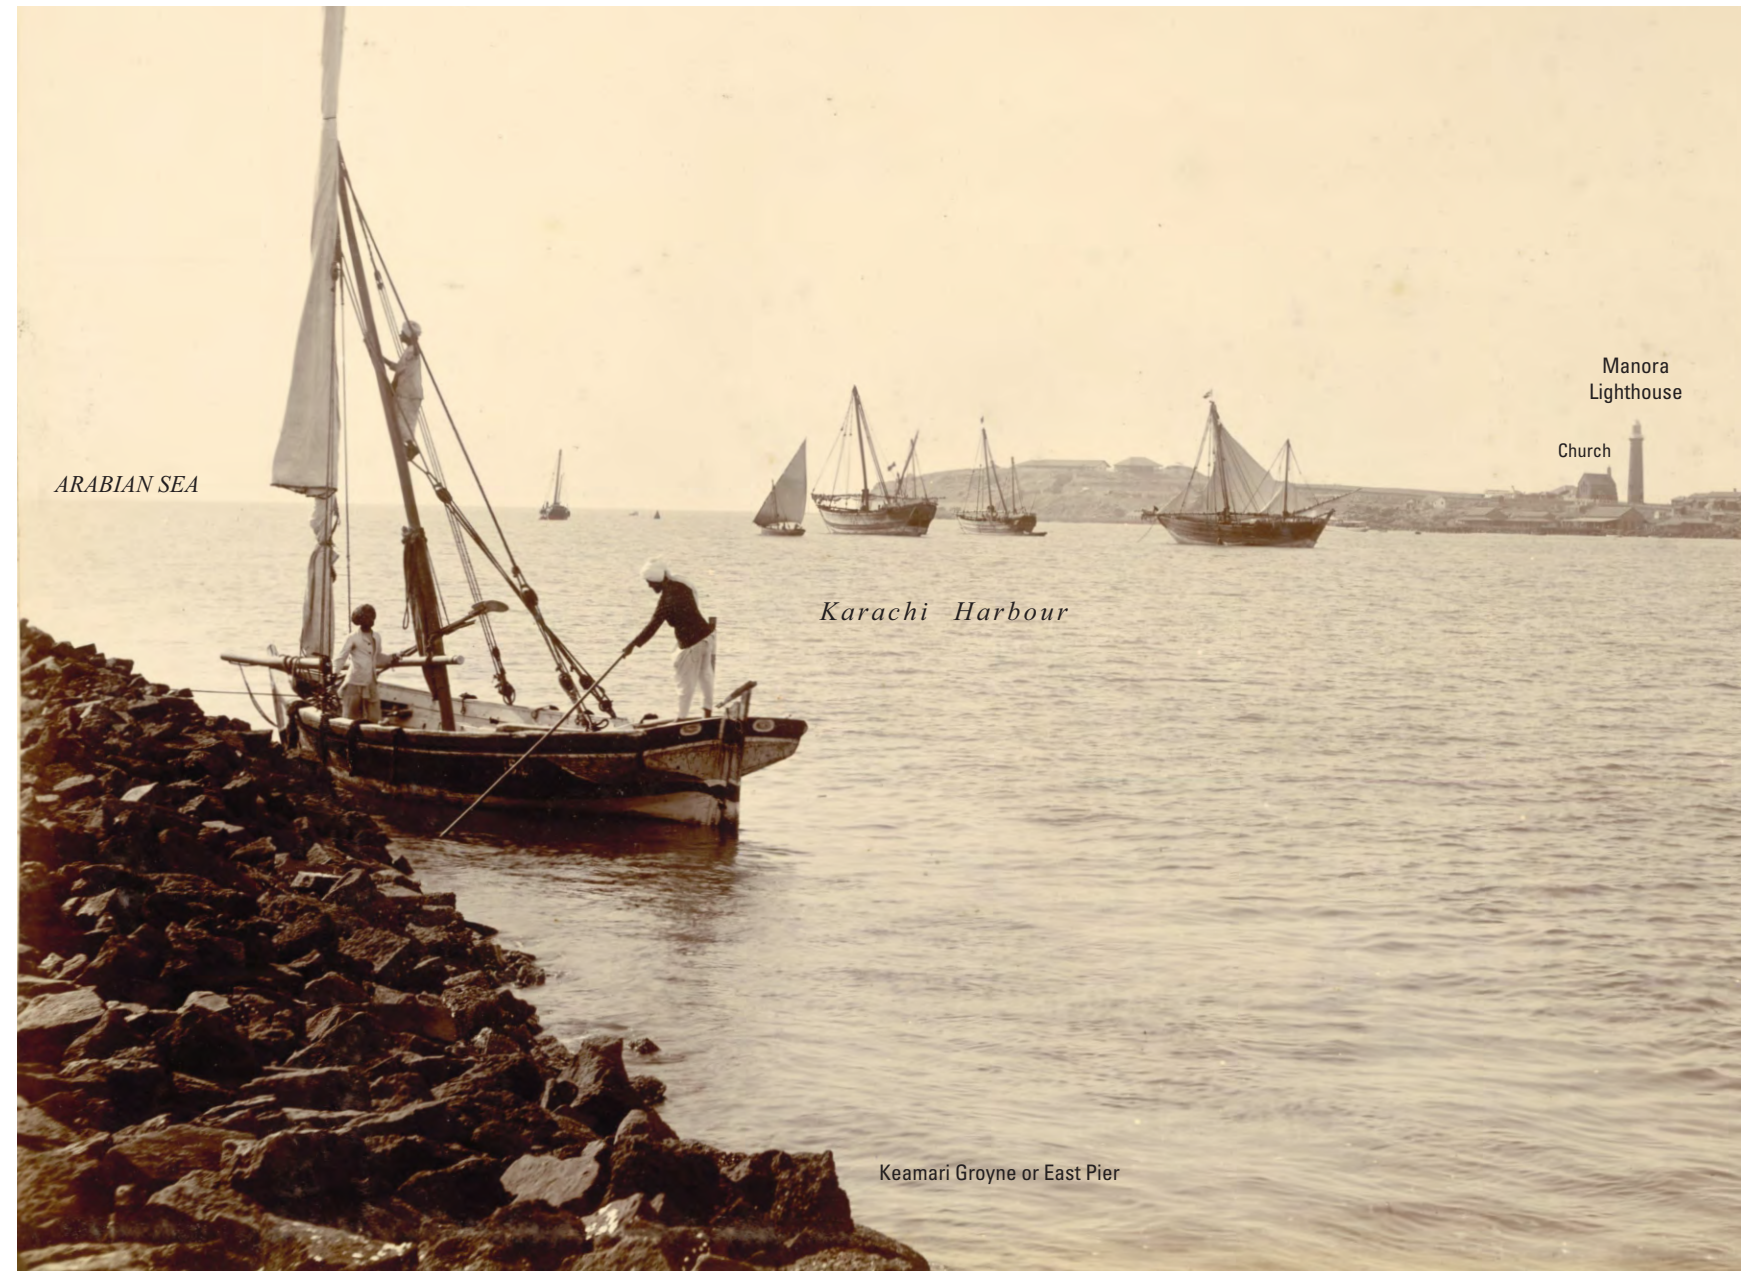
VIEW to southeast (mapped, p. 24). Manora Lighthouse dates the scene to 1889 at earliest (p. 8). From a photo collection attributed to an engineer who worked in India in the early 20th century; British Library 940/1(35).

Sailing vessels in lower Karachi Harbour several decades before the tsunami

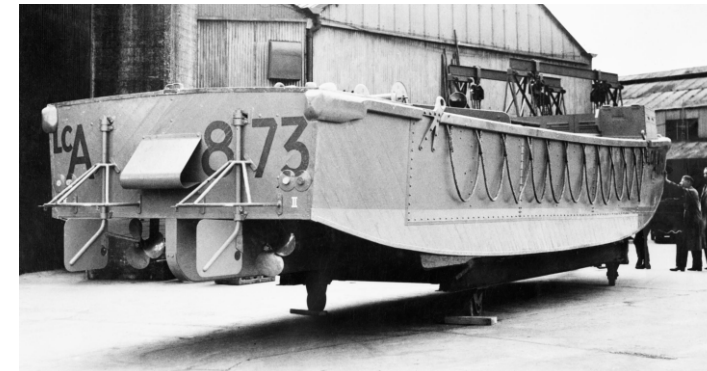
**The Landing Craft, Assault** made up part of the landing craft wing of the Royal Indian Navy. Three LCA flotillas were moved to Karachi in September 1945. According to Cyrus Cowasjee, landing craft provided ferry service between the Boat Basin and RIN naval training facilities (p. 27).

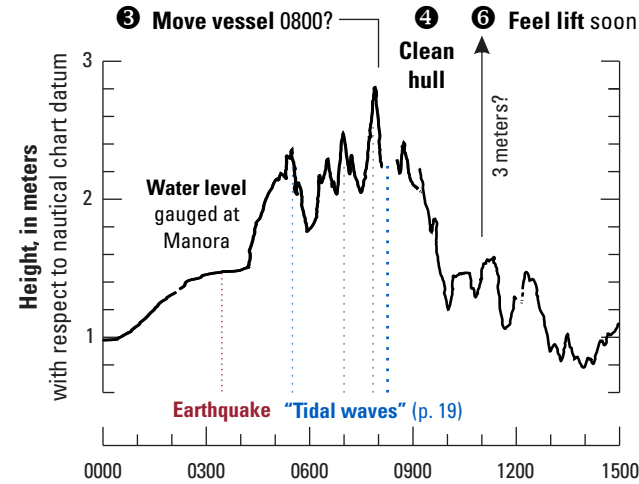
Timeline for key events in Mr. Fofindi's account (p. 29), using times he questioned in 2014

On the more leisurely **timeline below**, grounding takes place and hull cleaning begins on the falling limb of the higher high water of November 27. On November 28, during the most memorable event, the vessel is lifted most noticeably by the wave the *Times of India* called "the biggest." The vessel is assumed to have a draft of one meter unladen, and the shoal on which it is grounded stands 1.2 meters (4 feet) above chart datum, consistent with early twentieth-century soundings on the tidal flat east of Baba Island (chart excerpts, p. 29).

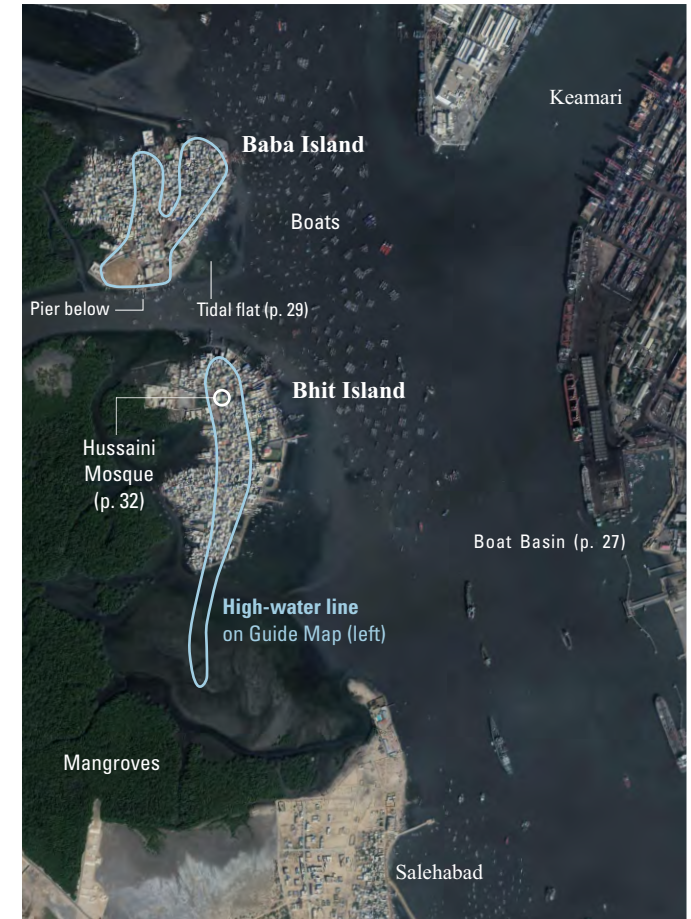
2017  
 0 500 METERS

MAP from Survey of Pakistan, Karachi Guide Map, published 1951, “corrected up to 1949.” Aerial imagery, dated December 26, 2017, from DigitalGlobe via Google Earth.

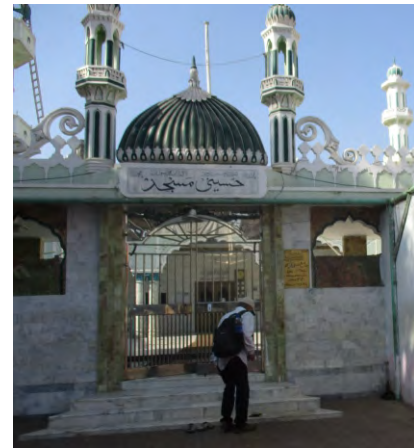
**Hussaini Mosque** is descended from a wooden structure that the 1945 tsunami entered, as judged from three of the accounts at right.

The reported flooding of the mosque provides a basis for estimating tsunami height. One of the men, Mr. Bhatti, stated that the mosque had been sited on high ground and founded on a stone platform. In that case, like the wharf decks beside the Boat Basin, the mosque floor may have stood above the level of most or all extreme high tides. Its flooding would then imply water levels above extreme tides such as those gauged one week before the 1945 tsunami (p. 28).

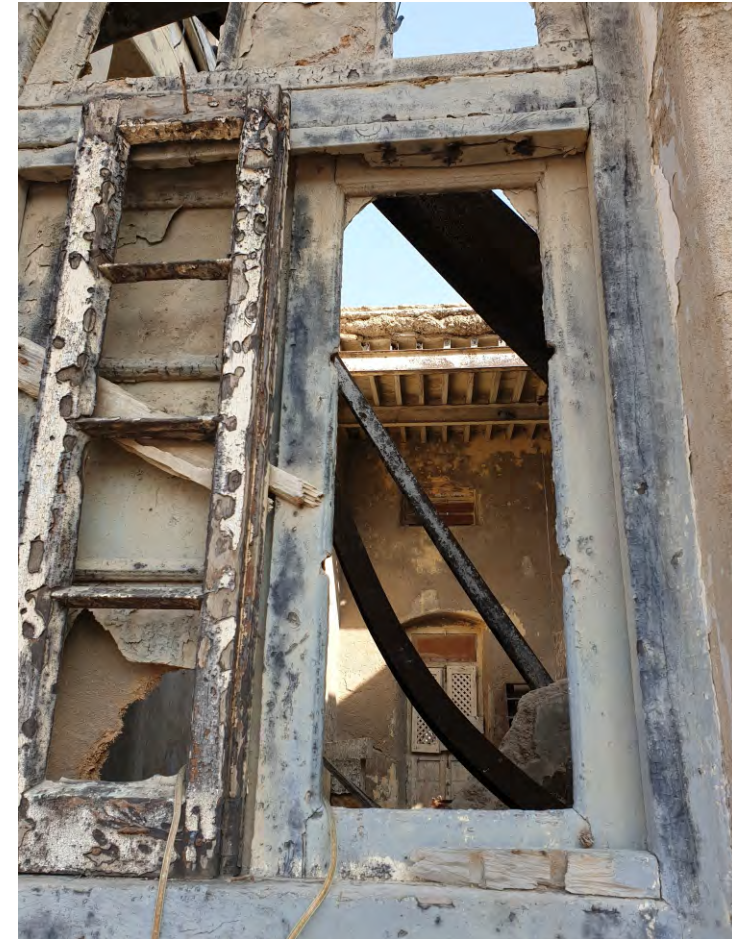
Published 1935  
100 METERS

**The Manora Observatory** of Karachi Port Trust (location, left) once housed electric and solar clocks, chronometers, aneroid barometers, and a telescope, and was maintained through 1964, but lost its roof by 2018 (above). Daily tide-gauge records from November 1945 would be inaccessible at best if last conserved in this building.

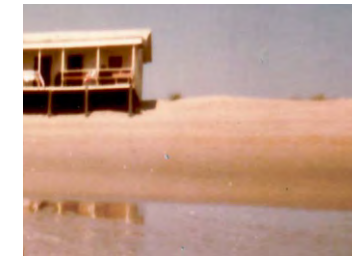
This family cabin at Sandspit, facing the Arabian Sea northwest of Manora (p. 5), reportedly went undamaged by the 1945 Makran tsunami.

Farther northwest stood cabins on Sandspit (maps, p. 5 and below). Cyrus Cowasjee (p. 26) testified in 2018 that the 1945 tsunami had no effect on his family’s cabin, and that this cabin floated away on a high tide in 1978 after undermining by beach erosion. In the 1969 photo below, the cabin floor appears to stand a few meters above a swash line.
