Tsunami Last Mile-MALTA21 exercise

Marsaxlokk (Malta), 5 November 2021

DRAFT¹ Evaluation report

Evaluation team, 5 April 2022

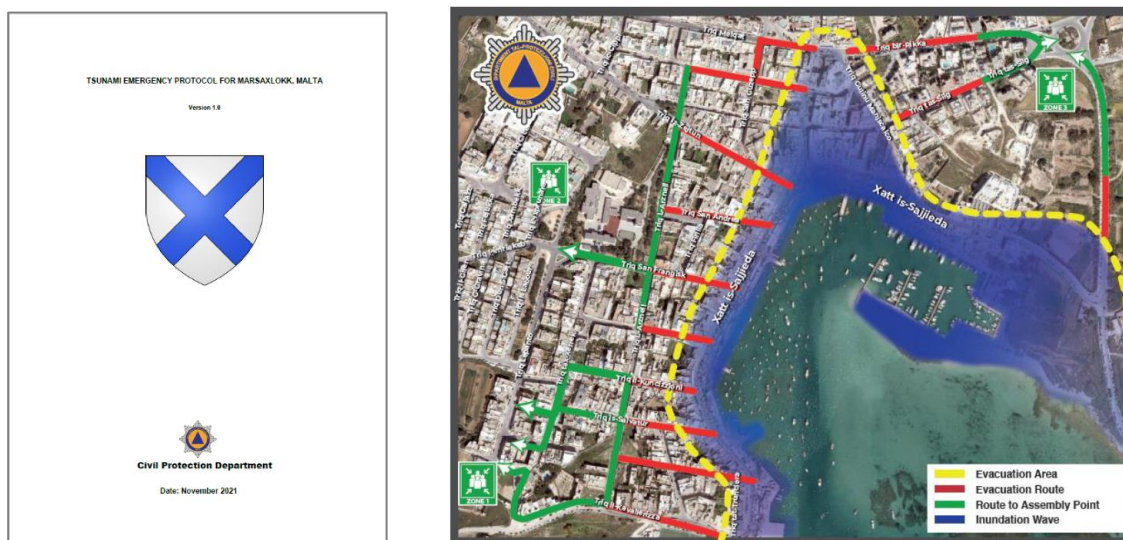
Figure 1: evacuation map for Marsaxlokk, included in the "Tsunami emergency protocol for Marsaxlokk, Malta" document prepared by CPD for the exercise.

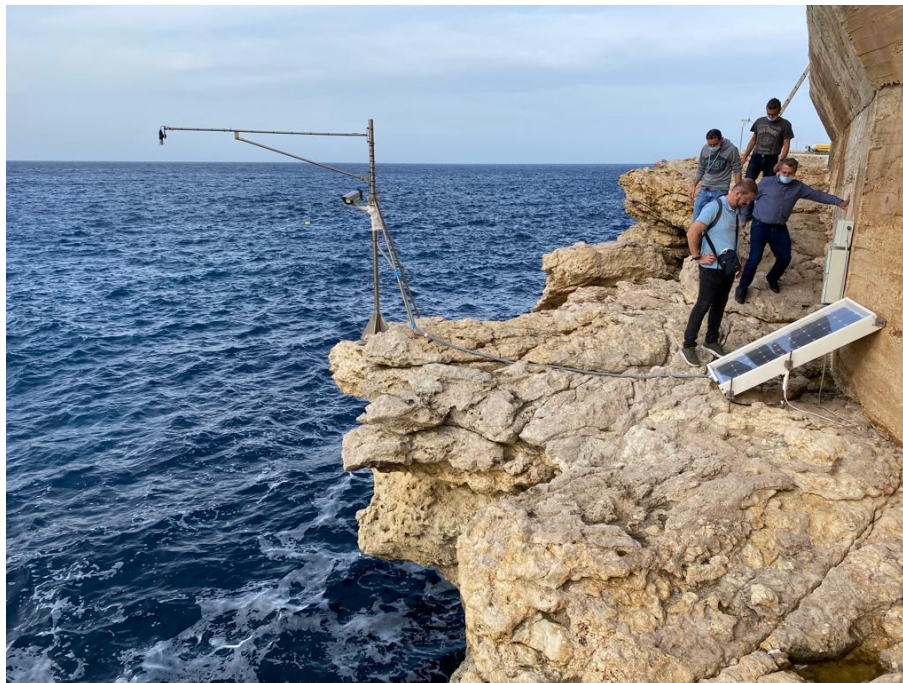
After a visit to IDSL-34 to refurbish its sensor, the plan of evacuation was revised to verify the installation of the temporary tsunami signage in terms of location and visibility. They were installed quite high at more than 2 meters to reduce the risk of vandalism, with the drawback of reduced visibility.

Figure 6: visit to IDSL-34 before the exercise, for maintenance intervention.

It was noted that the number of installed tsunami signs were also considered to be very few and rather far from the sea front, thus reducing its use and effectiveness: people would likely not know where to go. . As this activity was designated to the responsibility of the national Civil Protection, no further action was taken for the exercise.

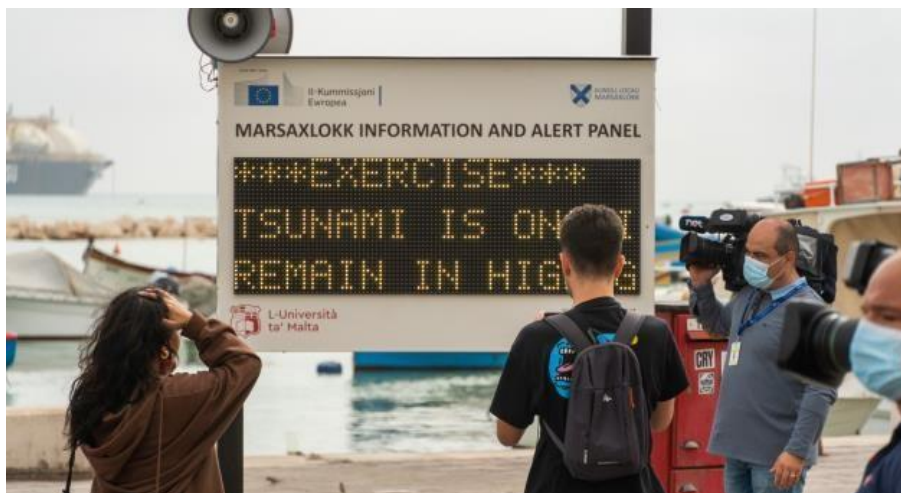
population. The use of the simulated tsunami height in the port of Marsaxlokk provided the possibility to perform automatic activation of the devices as a result of the computation of alerts through an algorithm developed by JRC.

Figure 8: Tsunami Alerting Device display during the exercise

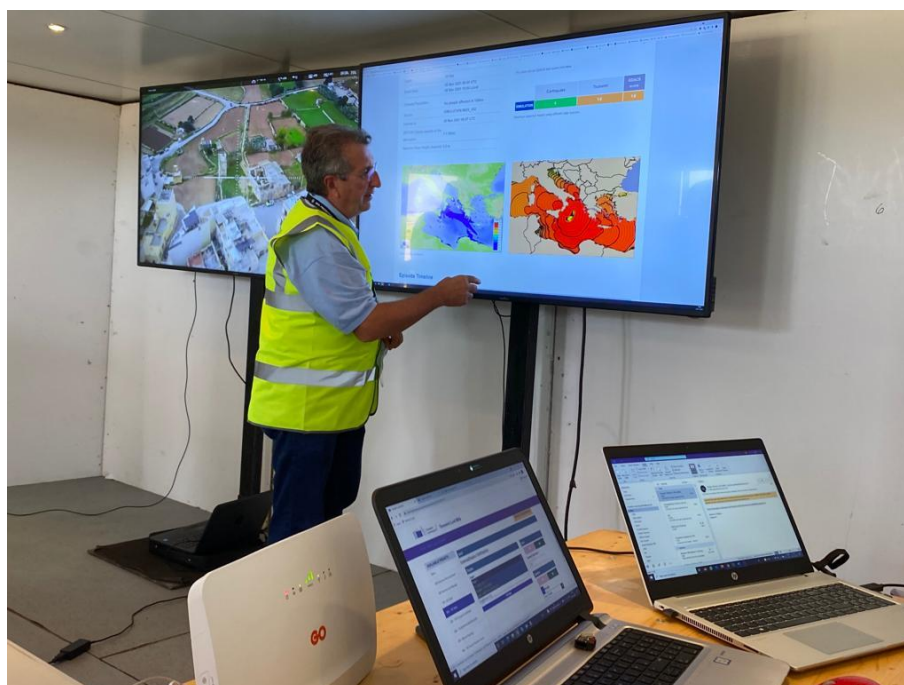
The CPD displayed the GDACS page to describe the event as soon as it was available. The page with an online self-updating set of plots of the IDSL data was always present on the main screen, until the automatic alert was activated.

Figure 11: GDACS page describing the event displayed in the on-site emergency operation centre of the CPD

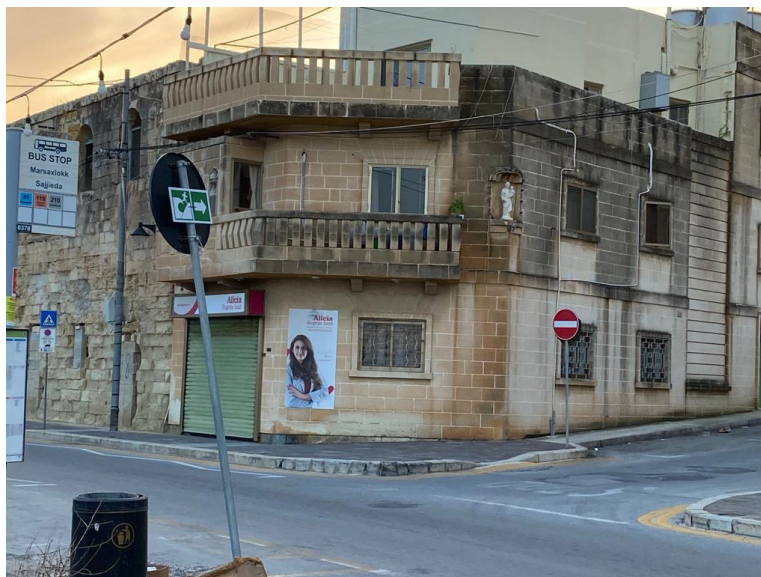
Figure 19: example of tsunami evacuation sign positioned along the roads for the exercise.

- Larger signage, which is visible from one or two crossroads away. The evacuation route should follow the natural (instinctive) route, going up to higher ground.

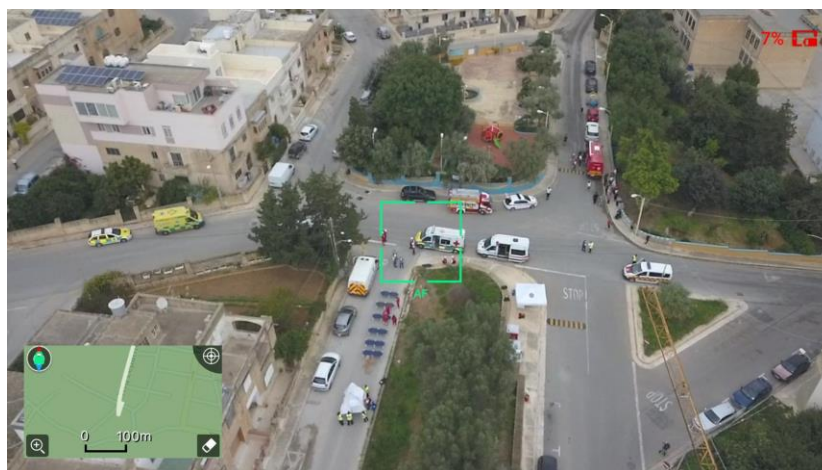
The sign of the assembly point was positioned quite high up and not so prominent at first glance.

Figure 20: aerial view of one of the gathering areas, showing the location and the space available for rescuers and population.

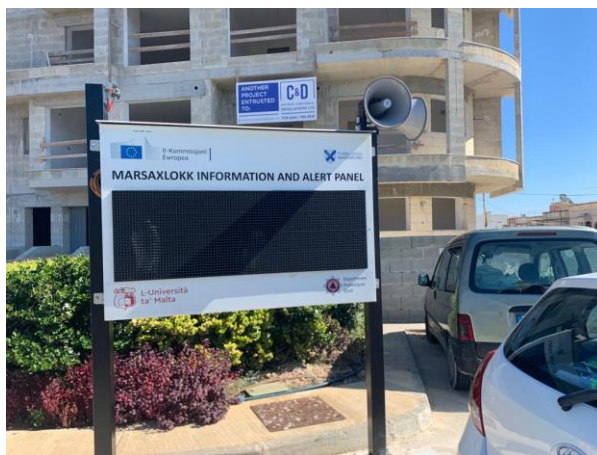
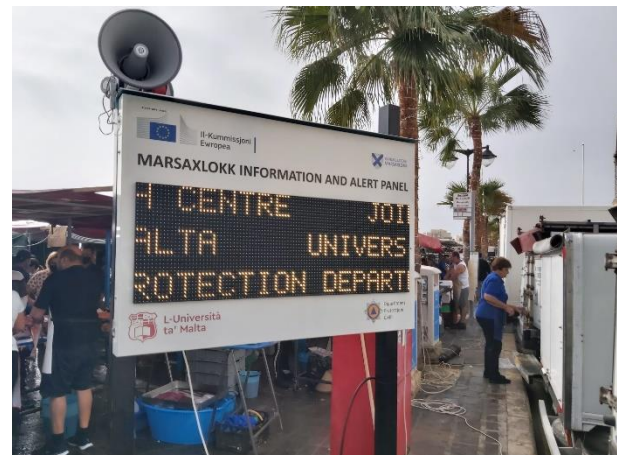
Figure 30: Information and alert panels in Marsaxlokk

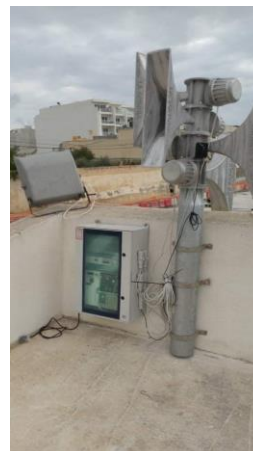
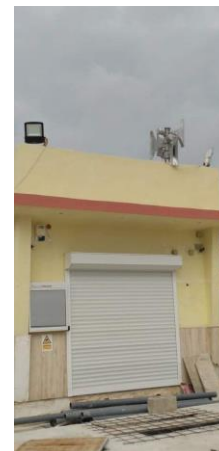
Figure 31: long range siren installation site

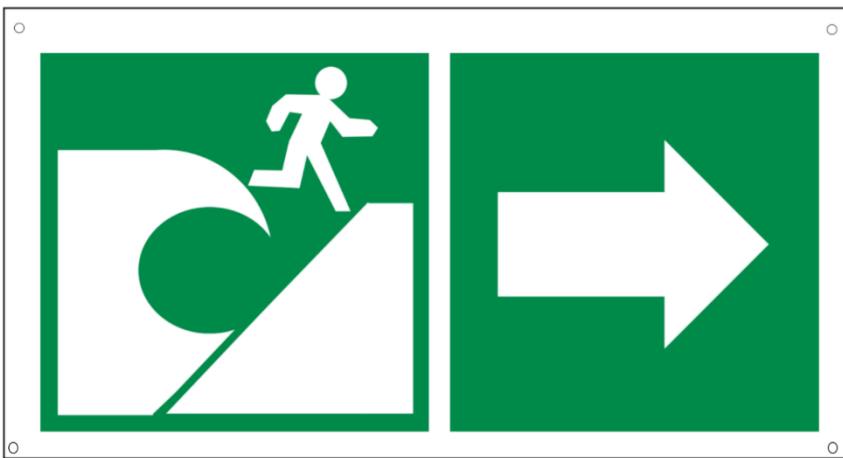
Figure 36: tsunami signs for Malta

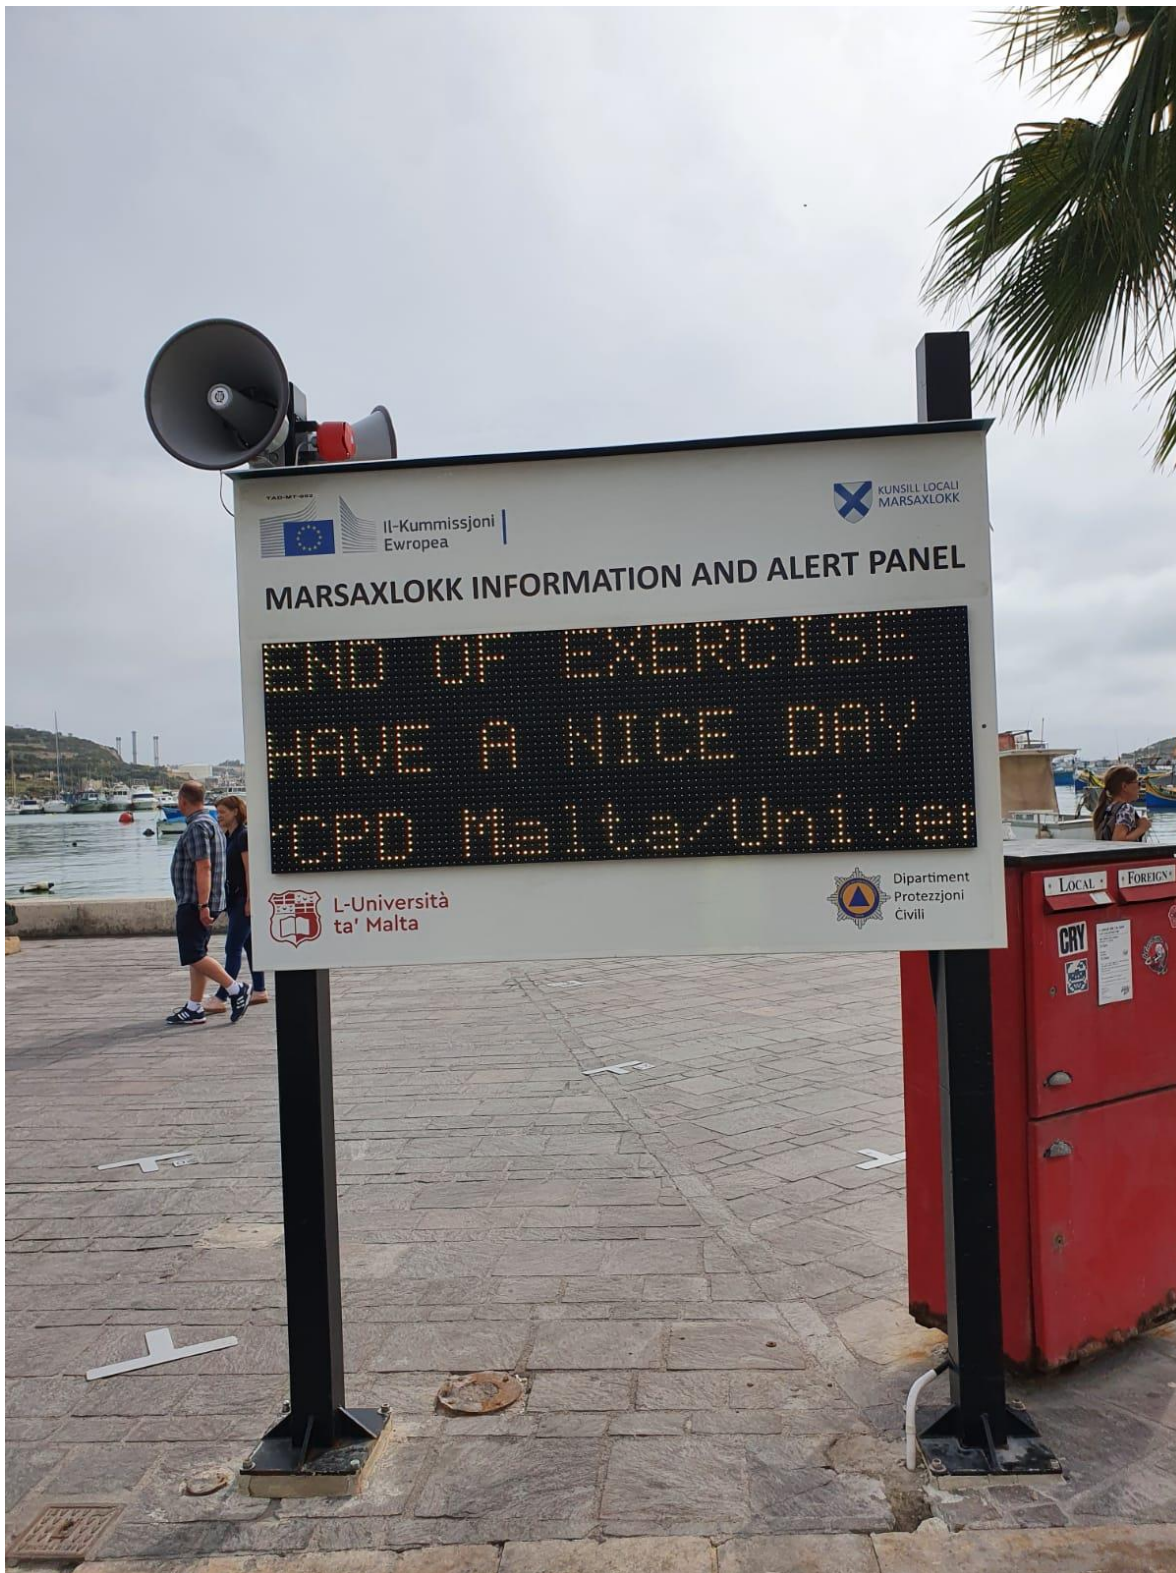
Figure 38: TAD panel showing message of "end of exercise"
