HOMEOWNER'S HANDBOOK TO PREPARE FOR NATURAL HAZARDS

REPUBLIC OF THE MARSHALL ISLANDS

By
Don Hess
Dennis Hwang
Karl Fellenius
Ian Robertson
Mark Stege
Ben Chutaro

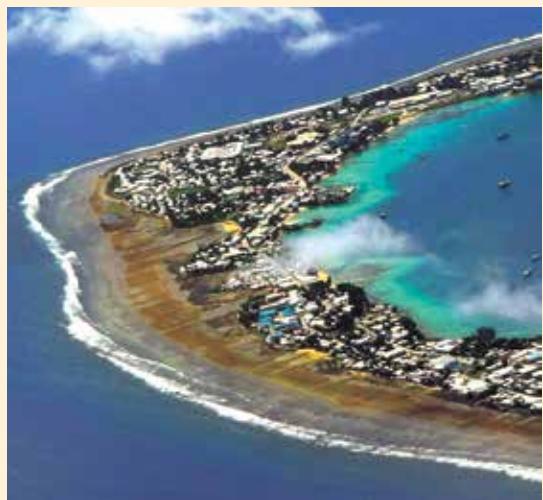
Figure 1-1. Lagoonal openings in D.U.D. were closed in 1944, followed by rapid development. (Images Courtesy of Marshall Islands Visitors Authority and D. Hwang)

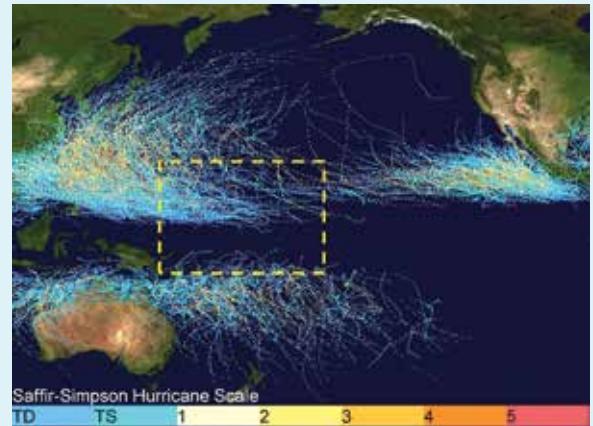
Figure 2-1. The history of tropical cyclones near the Marshall Islands (yellow dashed box) between 1985 and 2005. Although the Marshall Islands is not in the most intense region for typhoon exposure, there is still considerable risk. Note the even greater risk of typhoons to the west and north of the middle of the yellow dashed boxed area.

shown later, history indicates that typhoons are rare in the Marshall Islands, but frequent enough so that the threats must be planned for by the entire community (see Figures 2-1, 2-2, 2-4, and 2-5).

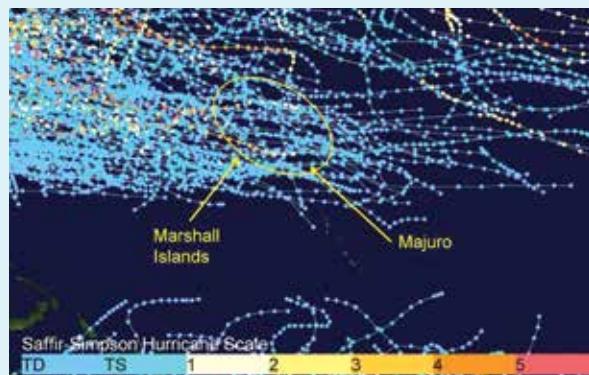
Figure 2-2. In an enlargement of the yellow dashed box in Figure 2-1, there were two typhoons that passed by the Marshalls from 1985 to 2005. During the same period, there were many tropical depressions and tropical storms that affected the Marshall Islands

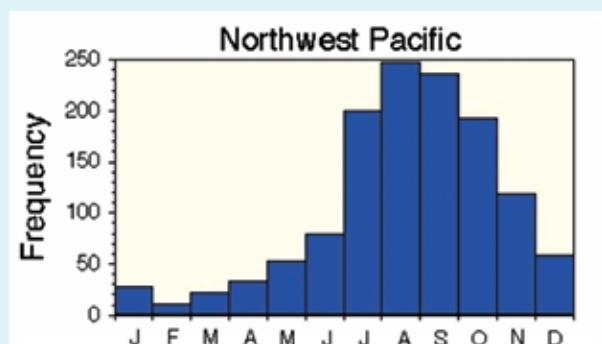
Figure 2-3. Frequency of tropical cyclones in the northwest Pacific by month (Pidwirney, 2012). The main season for tropical cyclones in the Northwest Pacific basin runs from July to November with a peak in late August/early September.

The area around the Marshall Islands is unlike other storm basins worldwide in that it produces tropical cyclones all year round, save for an “off season” with a distinct minimum in February and the first half of March (Figure 2-3).

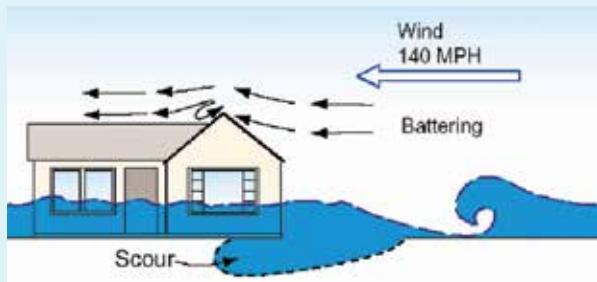
Figure 2-4. With any typhoon, there will be four key impacts that overlap. There can be Erosion/Scour of the coastline. In addition, there is Wave Inundation and Flooding. Finally, the impacts of High Winds must be planned for. Some of the impacts, such as erosion, scour and wave inundation may diminish for inland locations.

The evacuation measures in Part 3 of this book are primarily driven by potential wave inundation and flooding from a typhoon which can threaten life and property (see Figures 2-4 and 2-7). However, a tsunami may also drive the evacuation. The home retrofits in Part 4 of the book are driven by the wind impacts from the typhoon (see Figures 2-4 and 2-6). In addition, the elevation measures in Part 4 are meant to address more frequent, less intense flooding associated with weather events smaller than a typhoon or a tsunami.

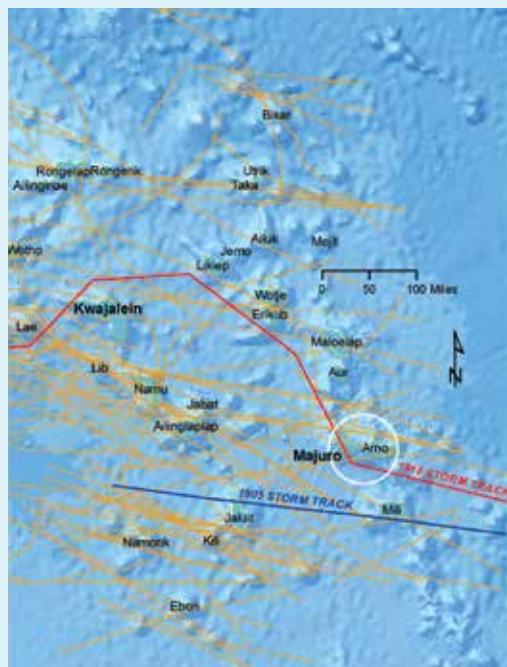
Figure 2-5. Climate researcher, Mark Stege, overlaid the work of Dr. Spennemann with IBTrACS storm tracks from 1958-2012 (see Knapp et al., 2010). The composite map shows the 1905 Typhoon (blue), 1918 Typhoon (red), and all storms 1958-2012. Majuro is circled. See the impacts of these storms in Figures 2-6 and 2-7.

The two typhoons that caused the most damage in the Marshall Islands occurred in 1905 and 1918 (Figure 2-5), when many of the islands were directly hit and there was significant property damage and loss of life. Dr. Dirk Spennemann used 20th century documents such as captain's ship logs and missionaries' letters to approximate the location and wind speed of the 1918 and 1905 storms.

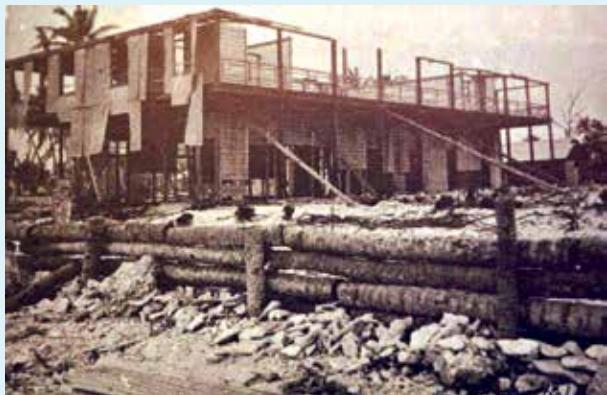
Figure 2-6. Typhoon Wind Impacts - Damage to the Catholic Girl's and Nuns' Living Quarters building in Jaluit after the 1905 typhoon. Note the blown off roof, which is common from the strong winds of a typhoon. In addition, there is water damage or inundation that overtopped the log seawall and eroded or scoured sediment behind the wall (Photo Micronesian Area Research Center).

Blown off roofs from a typhoon demonstrate the need for strong roofs and attachments to the wall and foundation. How to do this is shown in Part 3 for emergency shelters and Part 4 for houses.

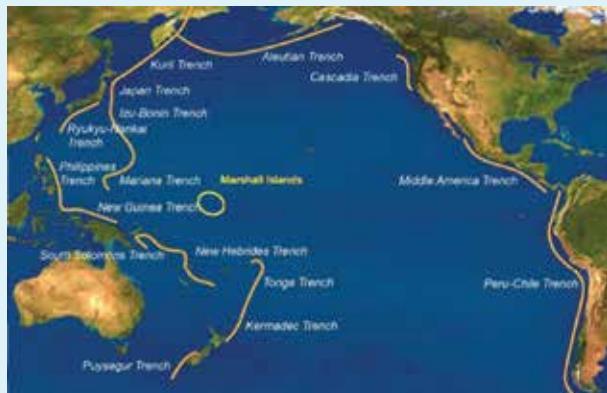
Figure 2-8. Around the Pacific Rim are a series of trench systems marked by orange lines where the ocean floor sinks under the overlying crust. Sudden movement at these trench systems cause subduction zone earthquakes, and if large enough, the generation of a tsunami by the displacement of large volumes of water.

Tsunamis are large surface waves caused by a major disturbance in the ocean such as a submarine earthquake, underwater landslide, volcanic eruption, or meteor impact. By far, the most likely cause for tsunamis in the Pacific will be from an earthquake associated with the major subduction zones around the Pacific Rim known, as the Ring of Fire (see Figure 2-8 and 2-9).

Some major historical tsunamis in the Pacific that impacted the Marshalls include the 1957 tsunami off the Aleutian Trench and the 1960 tsunami off the Peru-Chile Trench (see Figure 2-8 for the source/location of these events). Measured inundation depths were 10-13 feet (NOAA, 2011). Modeling of earthquakes from the Kuril, Mariana, and Ryukyu trenches estimate overland flow of 3-6 feet (see Robertson, 2015).

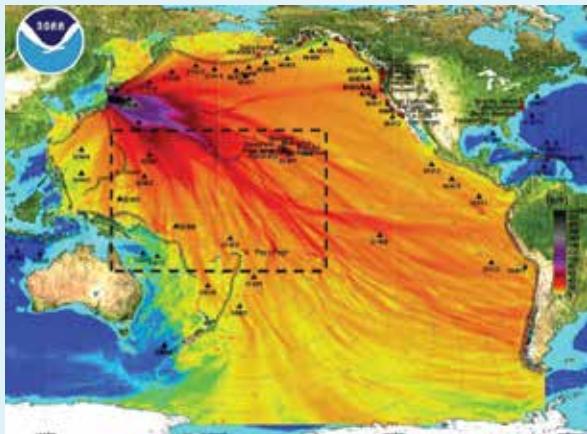
Figure 2-9. The large tsunami in Japan (Tohoku Tsunami) on March 11, 2011 was caused by a great earthquake along the Japan Trench (Figure 2-8). This is where ocean crust is being subducted or thrust under the crust to the west. The colored bar to the right in South America is water height with a top value of 240 cm or over 8 feet in the open ocean. Image courtesy of NOAA.

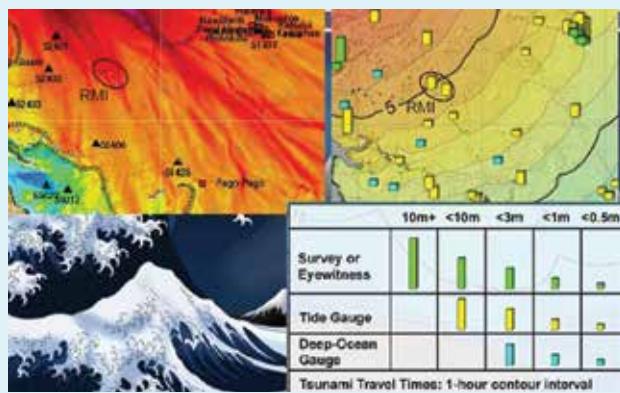
Figure 2-10. For the Tohoku Tsunami, the estimated water height at the Marshall Islands was under 1 meter or 3 feet (see Robertson, 2015). The Marshall Islands were fortunate since the time of the tsunami coincided with a low tide of 3 feet.

As tsunamis approach land, they slow down in speed and grow in height. This growing effect is most pronounced on a gently sloping continental shelf. For example, in Japan, the wave grew over 10 meters (greater than 33 feet). For Pacific Atolls, the shoaling effect is much less because instead of a gently sloping continental shelf, there is a steep and abrupt drop off to over a mile deep just outside of the ocean reef crest of the atoll. **The Tohoku tsunami waves were estimated at less than 3 feet when it reached the Marshall Islands (Figure 2-10).**

Because it was low tide in the Marshall Islands at the time the tsunami struck, there was limited inundation. Experts at the Weather Service Office feel the outcome could have been much worse if the tsunami struck during a high tide, with the potential for significant inundation and flooding damage.

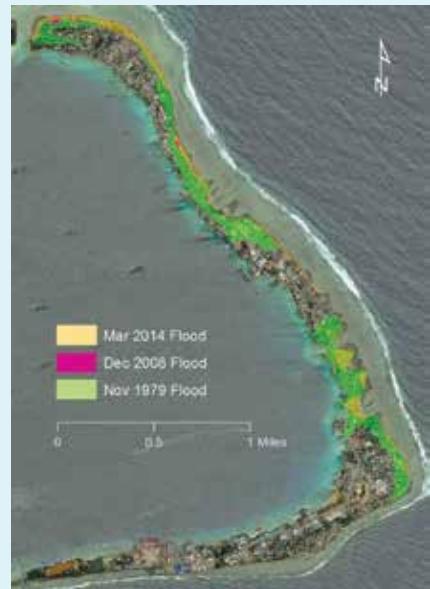
Figure 2-11. This map shows the estimated extent of flood inundation from extratropical storms in November 1979; December 2008; and March 2014. The 1979 event was the largest and in several locations, the inundation crossed the island.

Extratropical storms are mid-latitude storms (outside tropical latitudes) that can produce long-wavelength (swell) which can travel great distances and impact the Marshall Islands. Some of the most notable flooding events from extratropical storms occurred in November 1979, December 2008, and March 2014 (see Figure 2-11).

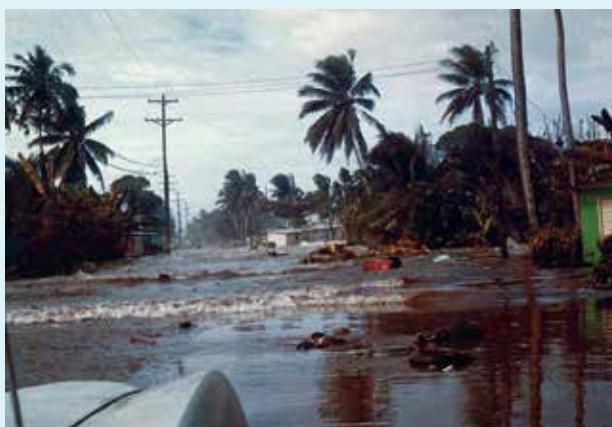
Figure 2-12. Wave inundation and flooding during the 1979 extratropical storm in Majuro. Flooding at this location crossed the atoll. In some locations a channel was cut into the atoll. Photo courtesy of Hamilton Library, University of Hawai'i Pacific Collection.

In late November and early December 1979, there was an extratropical storm that caused huge waves which traveled far distances and washed water over the island causing much damage (see Figures 2-12 to 2-15). The water was able to cut channels in the atoll. Because the area of wave generation was far away, it was actually clear sunny weather in Majuro.

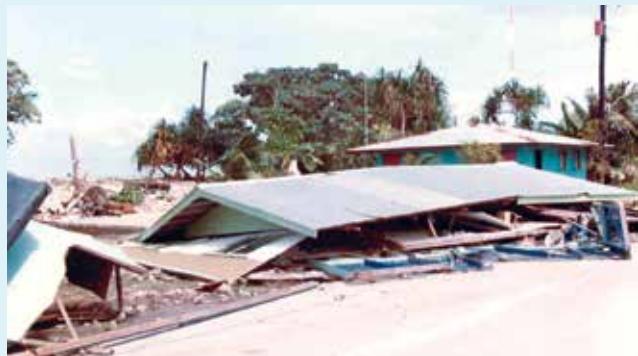
Figure 2-13. During the 1979 inundation event, there were 100 to 300 houses that were destroyed. Many more were damaged. Wave inundation such as this is the reason elevating houses is covered in Part 4 of this book in order to reduce the risk of damage. Photo courtesy of Hamilton Library, University of Hawai‘i Pacific Collection.

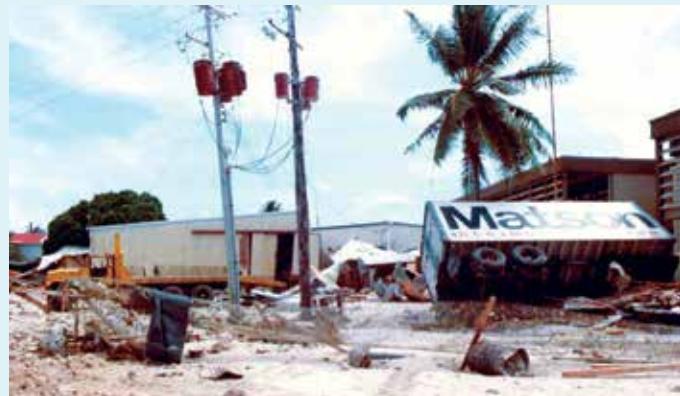
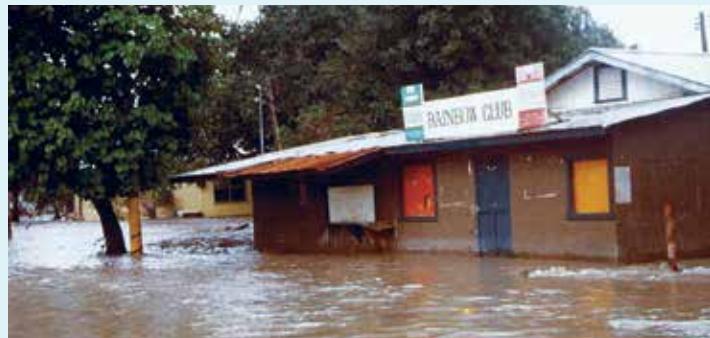
Figure 2-14. During the 1979 event, there was an estimated \$26 million in property damage and major portions Djarrit and Delap were covered in sediment. Photo courtesy of Hamilton Library, University of Hawai‘i Pacific Collection.

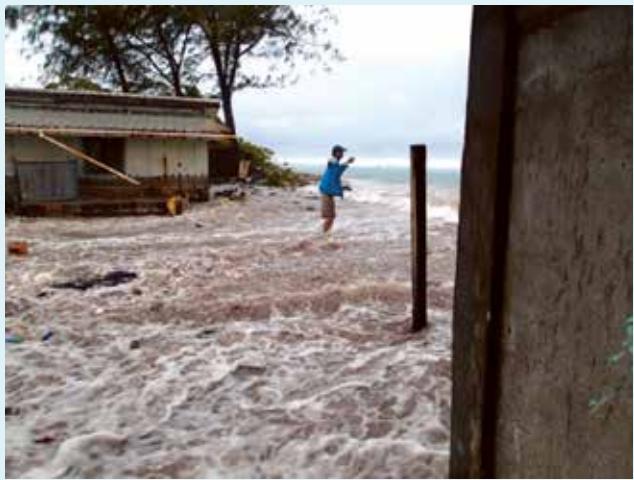
Figure 2-16. Inundation in March 2014 was a result of swells generated by an extratropical storm raising water levels above normal. This made the shoreline of the Marshalls especially susceptible to further inundation and flooding from King Tides. This made the shoreline of the Marshalls especially susceptible to swell generated by an extratropical storm. The high waves inundated parts of Majuro, the Capital, as well as other communities in the outer islands, including Arno and Mili.

In March 2014, there was again a significant inundation event that resulted from a combination of swells from an extratropical storm and a “King Tide” (see next Section 2.4). Inundation and damage started occurring several hours before the King Tide. The damage from this event can be seen in Figures 2-16 to 2-18.

Note that using this forecast tool, inundation would have been predicted with the greatest threat between the afternoon of March 2, 2014 and the late afternoon of March 3, 2014. This is reflected in the actual damage seen in Figures 2-16 to 2-18. The figure shows the inundation was a combination of high tides and extratropical swell. This tool can help emergency managers and the public plan for potential inundation events days in advance.

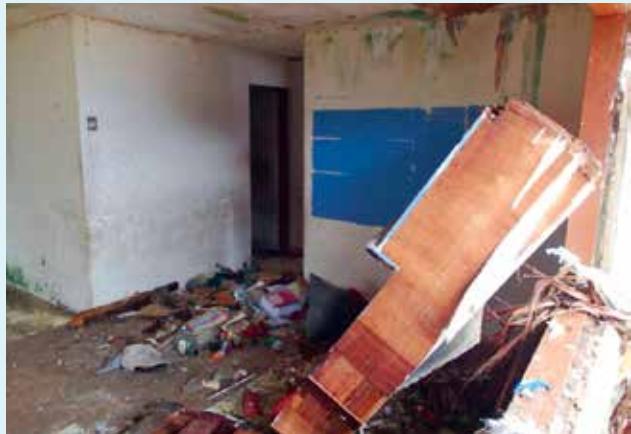
Figure 2-17. During the March 2014 event, about 110 homes were damaged and about 940 family members were displaced and sought sanctuary in government-designated shelters and churches. It is because of damage such as this that Part 4 of the handbook covers tools to reduce damage such as elevating of structures or building with flood resistant materials.

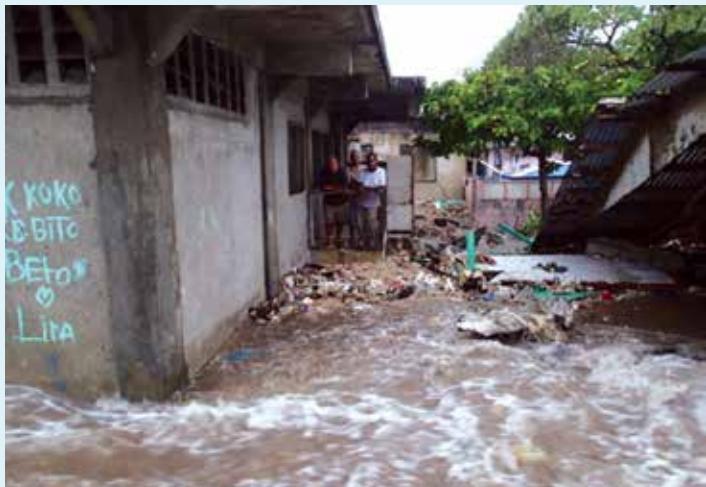
Figure 2-18. Even if a structure is elevated or built with flood resistant materials, during a typhoon or major tsunami, shelter should be to structurally sound buildings such as covered in Part 3 of this book. It may be acceptable to shelter in place for smaller events, such as the March 2014 floods, however, it is more than likely that inundation will be unpredictable (larger or smaller than anticipated). Thus if in doubt, evacuate to designated shelters.

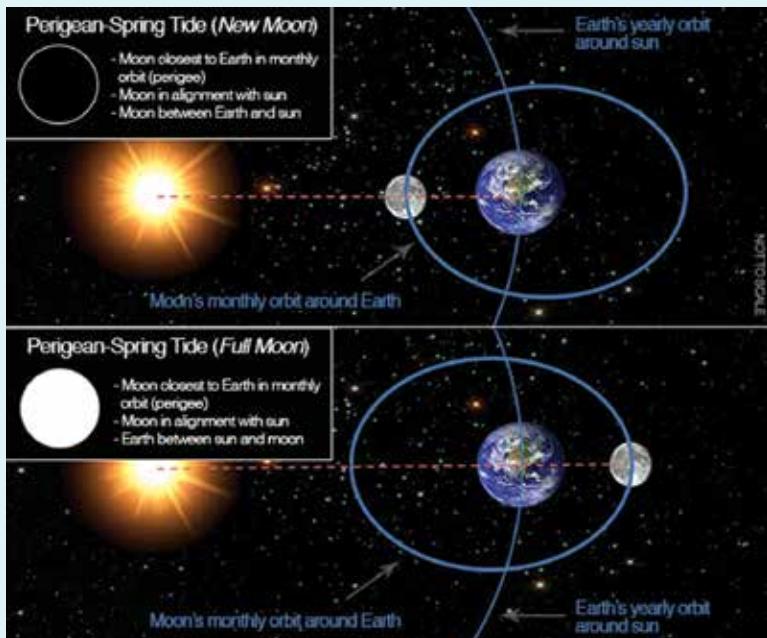
Figure 2-19. The highest tides of the month occur during the new moon (top) and the full moon (bottom). Then gravity from the moon and sun combine to create the strong tides. Even higher tides occur 3 to 4 times per year when the moon is full or new, and the moon is at its closest position to the earth. The moon's distance to the earth varies since its orbit is not circular but elliptical. This creates a large variation in gravitational pull. At the moon's closest distance during a new or full moon is when there are King Tides. Image courtesy of NOS and NOAA.

King Tides are simply the highest high tides of the year. They are also associated with the lowest low tides of the year. Figure 2-19 explains how King Tides develop.

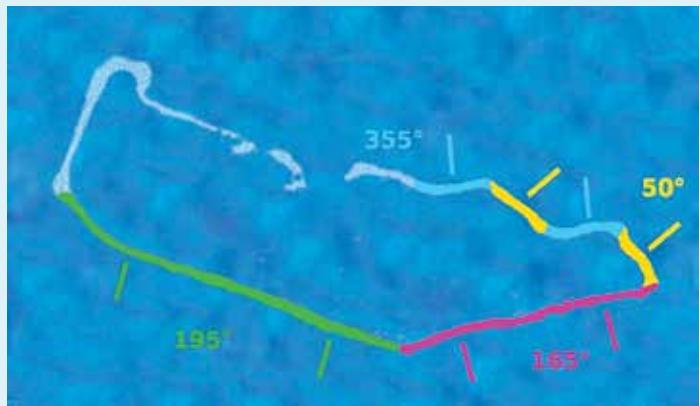
Figure 2-20. Majuro has been color coded into four shoreline sectors, depending on the orientation of the coastline with incoming waves. The shoreline sectors are perpendicular to waves coming in at 50, 165, 195, and 355 degrees of the compass. Each color represents a forecast of potential inundation. No forecasts are explicitly provided for the gray-shaded land areas.

associations of the U.S. Integrated Ocean Observing System (www.pacioos.org). PacIOOS has a forecast inundation tool for sea level that includes tides and swells. The tool for the Marshall Islands is available at: (http://pacioos.org/data_product/SLpred/Maj_Exc.php). The inundation tool is explained in Figures 2-20 to 2-21.

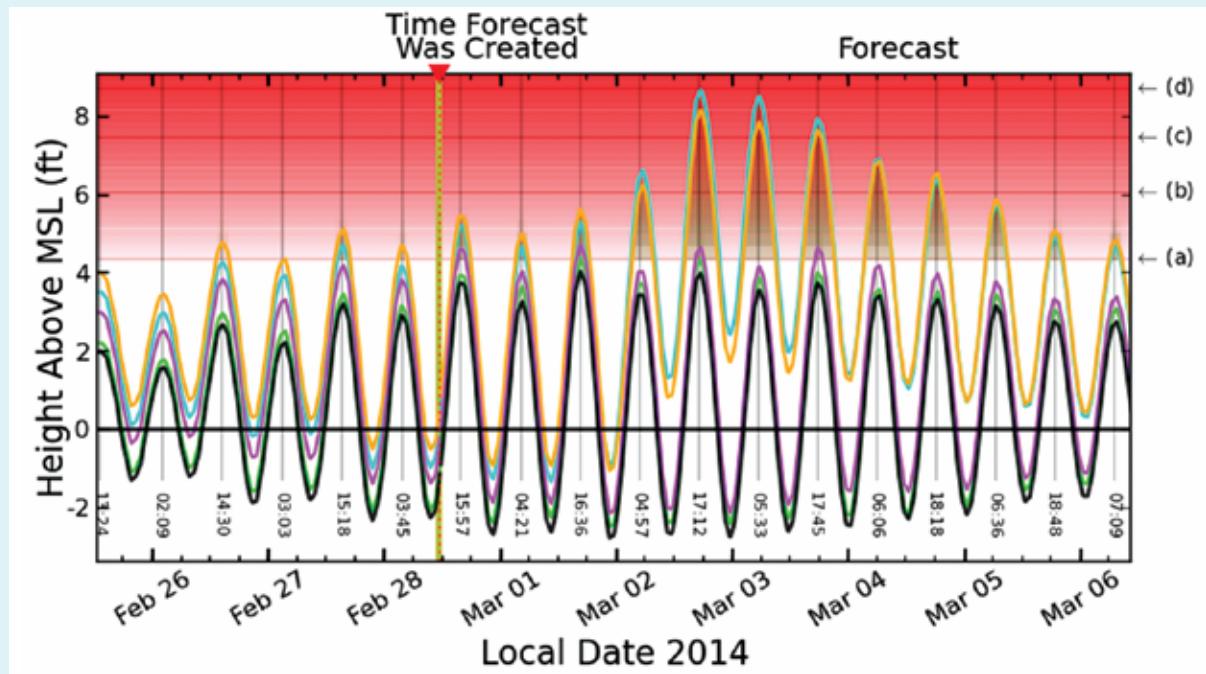
Figure 2-21. The black curve is a sea level forecast that does not include effects due to swell waves. This curve will reflect primarily the large spring tides and larger King Tides discussed in Figure 2-19. On top of the black curve are the Cyan, Orange, Magenta, and Green curves which will show the Inundation Height that indicates the potential for inundation of the land for the different sectors of Majuro due to swell waves (e.g., extratropical storms) added to the tides (high and low). If the forecast inundation height extends into the red shaded area, inundation is likely in low-lying areas. For the three days prior to the “Time Forecast Was Created,” the colored curves are showing the last valid forecast for each date/time. The forecasts are updated hourly.

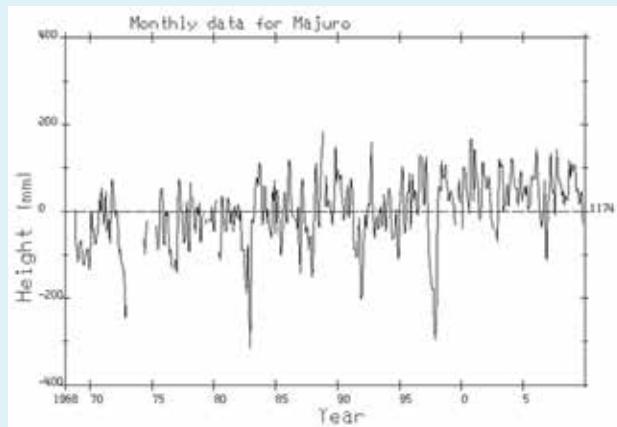
Figure 2-22. Tide gauge data for Majuro from 1968 to 2010 shows sea level has been rising in the area at a rate of about 3 mm per year. Data from NOAA Center for Operational Oceanographic Products and Services. The extreme lows in 1998 and 2003 are associated with El Niño events.

Another factor adding to the hazard risk in the Marshall Islands is sea-level rise. Sea-level rise is due to global warming, the melting of ice sheets, and the expansion of warmer water. Tide gauges on Kwajalein and Majuro have been used to document the extent of past sea-level rise (Figure 2-22).

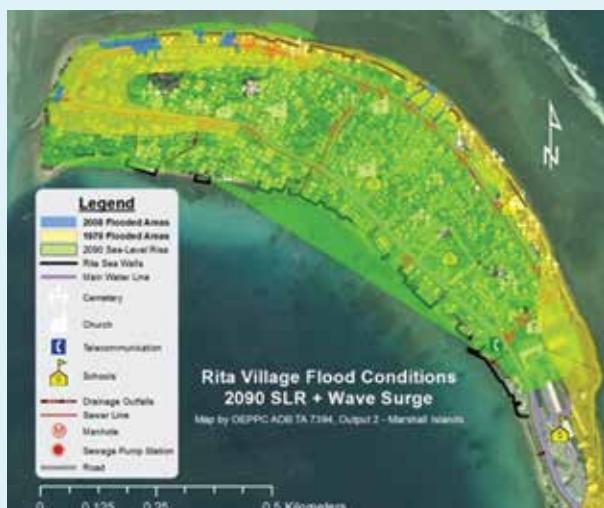
Figure 2-23. The extent of wave inundation is mapped for extratropical storms in 1979 (in yellow) and 2008 (in blue). In addition, there is a projection for sea-level rise in the year 2090 using an estimated rise of 0.62 meters or 2.40 feet (in green). This is an example of flooding or wave inundation being caused by numerous events (extratropical storms and sea-level rise). Other risks for wave inundation and flooding can come from a tsunami or typhoon. Map courtesy of the Office of Environmental Planning and Policy Coordination and created by the MarTina Corporation.

Sea-level rise is expected to accelerate in the future, but the exact amount is not certain. A projection of the impacts of sea-level rise is compared with inundation from the 1979 and 2008 extratropical storms in Figure 2-23.

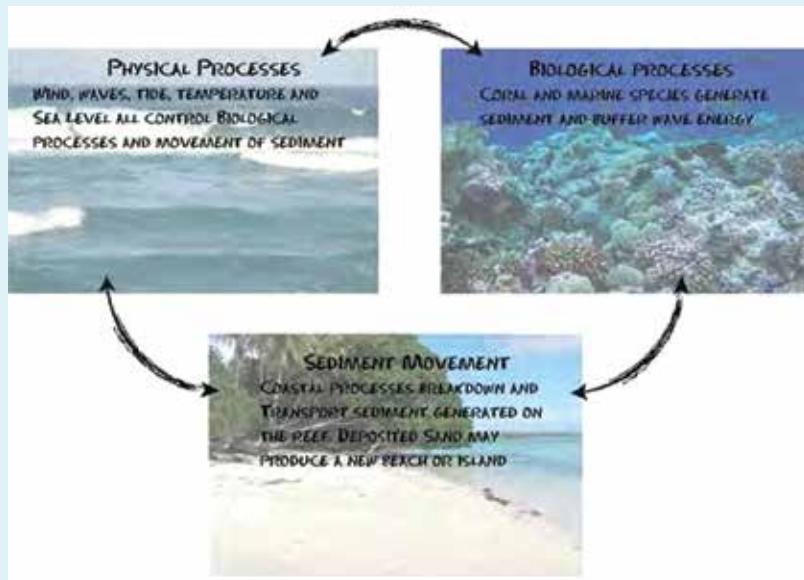
Figure 2-24. Some physical coastal processes include wind, waves, currents, tides, temperature, and sea level. They continually drive the sediment produced via biological processes and result in sediment movement that builds and erodes islands. Marine deposition on geological timescales and terrestrial deposition from episodic flooding are the overriding large-scale processes that determine where sediment accumulates over time.

Coral reef islands are naturally dynamic features, with their shoreline moving as a result of changes to the physical and biological environment. Reef islands are made up of sediment that is generated by the breakdown of living material on the adjacent reef. Coastal processes are physical and biological mechanisms that operate along a coastline, bringing about various combinations of sediment transport, erosion, and deposition. Human use of Majuro requires space and produces waste, which affects these natural processes and changes the location and relative proportions of erosion and accretion that would otherwise be present if it was an unpopulated area. Physical and biological processes are involved whether a coastline is eroding or accreting (Figure 2-24).

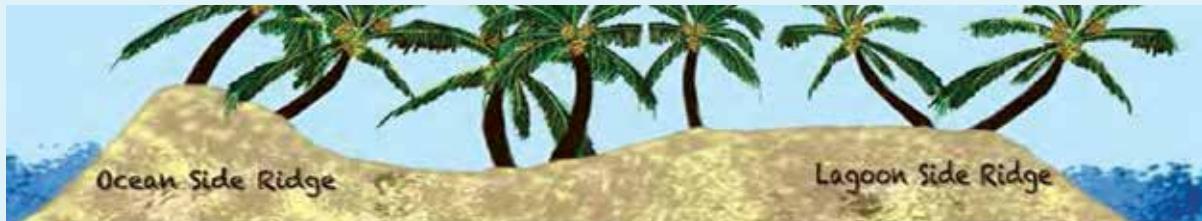
Figure 2-25. The ridges of an atoll serve the important function of protecting inland areas from wave inundation and flooding. Thus they should be maintained and enhanced if possible.

Tides allow higher waves to reach the island at high tide. Island morphology shows that the highest elevation of an atoll island is on the ocean side berm (ridge), which is made up of coarse coral sediment and larger shingles (Figure 2-25). Lagoon shorelines are exposed to smaller waves, resulting in smaller berms made up of fine sediment.

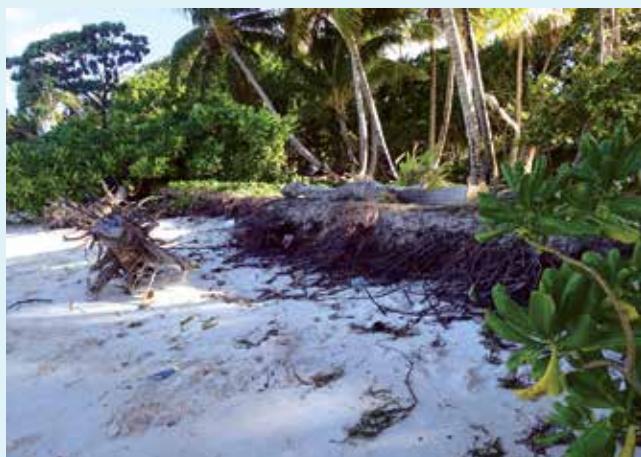
Figure 2-26. Erosion of the coastline at Laura, Majuro. Erosion is a serious hazard as it causes the shoreline to move inland and thus makes houses and buildings at increased risk from wave inundation and flooding. Erosion can be caused by physical processes associated with a tropical cyclone, tsunami, extratropical storm, and/or sea-level rise.

Erosion - When more sediment leaves a shoreline area by physical processes than is deposited by biological and physical processes, than erosion of the coastline occurs. This is typically seen by retreat of the shoreline and a vertical cut in the vegetated dune (Figure 2-26).

The biological processes on Majuro's reef are significantly degraded due to the developed shorelines and nearshore herbivore fishing pressure in proximity to the urban center. Therefore, physical processes are likely more eroding rather than depositing sediment from biological processes over time (Figure 2-26). Coastal protection services from the ecosystem are slowly diminishing via bioerosion. Nutrient loading from run-off and sewage discharge is the primary local point source cause for the reduced ability of the reef to calcify as it becomes more algae-dominated than coral.

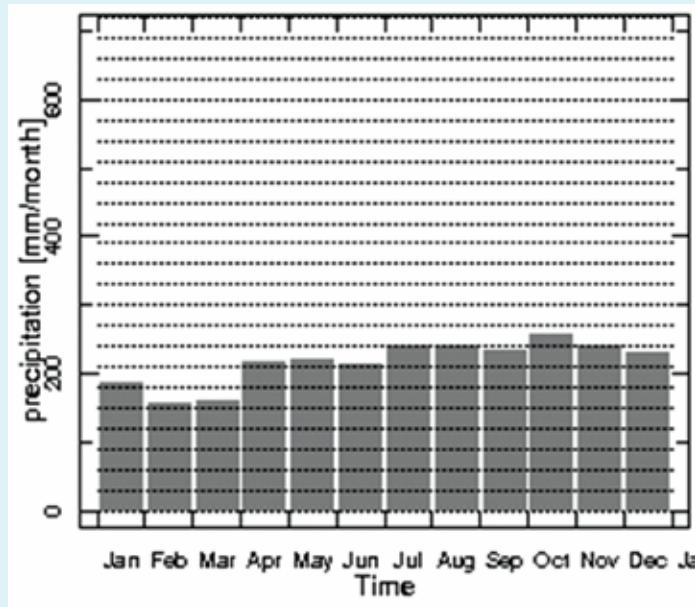
Figure 2-27. Average monthly rainfall for Majuro Weather Station is indicative of the entire Marshall Islands, where historically the dry season has been most prominent in January and extending into March, and possibly April during severe conditions. Compiled by climate researcher Mark Stege.

Drought is directly related to the amount of rainfall the Marshall Islands receive. Weaker trade winds in the summer from April to October coincide with greater rainfall in those months, while stronger trade winds during the winter from November to March coincide with decreasing rainfall and the dry season most prominent starting in January (see Figure 2-27).

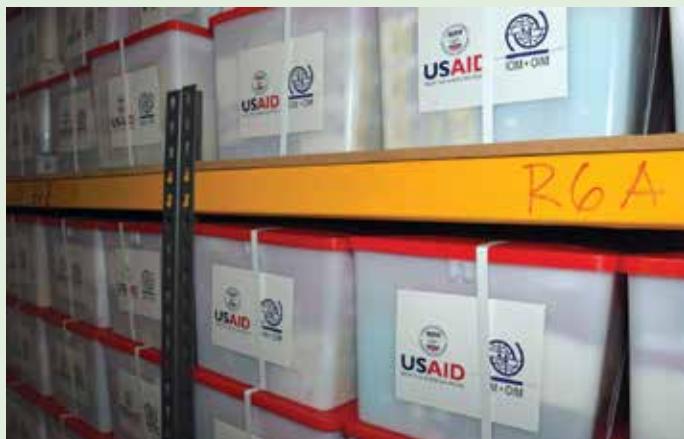
Figure 3-1. Although hygiene kits such as from IOM and USAID may be available after an emergency, it may still be useful to have your own evacuation kit with supplies. Common items in your evacuation kit are listed below. The advantage of having your own kit is that you can customize it to your own family's needs. In addition, the supplies would be available not only after an emergency, but before or during as well.

During an emergency situation, such as a typhoon, and especially a tsunami, it may be necessary to leave your home quickly and go to a shelter. In Majuro, the government and Red Cross, along with USAID and the International Organization for Migration (IOM), may give out supplies after an event (Figure 3-1). However, there may not be enough supplies, or an event may not be large enough to trigger the release of aid. Also if you are on one of the outer islands, the availability of outside assistance is likely to be delayed.

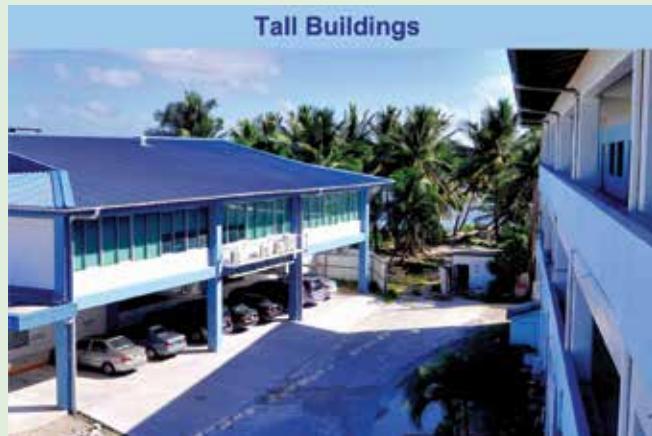
Figure 3-2. For a strong tsunami or typhoon, evacuation to buildings with two floors or more is required. All things being equal, the taller the building the better. This photo taken from the third floor of the Assumption School (right) is of the two floor Administration Building for the College of the Marshall Islands (left). Both buildings are considered shelters for only the second floor or above.

Because of the low elevation in the Marshall Islands, a shelter must be a tall building with two floors or more (Figure 3-2).

Criteria	Comments	✓
1. Tall building	Use second floor or higher. The taller the building the better if in good condition (Figure 3-2).	
2. Reinforced concrete	Best – Beam-column moment frame with open lower floor (Figure 3-3); Good – Moment frame with CMU infill on first and second floors (Figure 3-4); Acceptable – CMU walls – (solid grouted – concrete and rebar fill the holes) and under 20 years old (Figure 3-5).

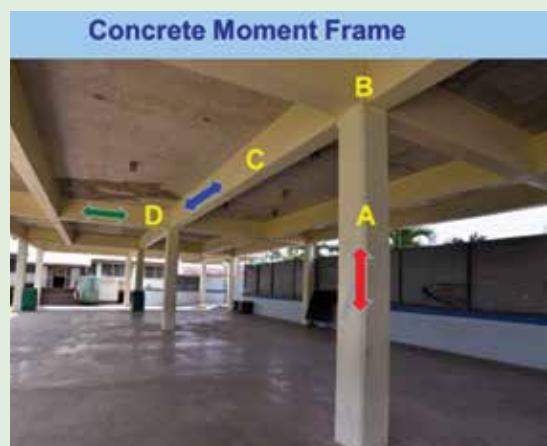
Figure 3-3. A Concrete Moment Frame has: (A) columns of concrete that are reinforced with rebar and attached rigidly at beam-column joints (B) to reinforced concrete beams such as at (C) and (D). Forces from high wind or fast moving water are resisted by the strength of the beams and columns. For example, forces in the direction of the green arrow are resisted by beam (D), in the direction of the blue arrow by beam (C), and in the direction of the red arrow by column (A). In addition, the lower floor is open. This allows water from a tsunami or typhoon to pass under the building without applying large forces from the side to the structure.

Another important criterion is for the building to have a strong structural system. The Concrete Moment Frame is structurally strong for both vertical loads (gravity) and lateral loads (wind, seismic, and flowing water) (Figure 3-3).

In the urban areas of the Marshall Islands, building with concrete is common. There are advantages and disadvantages to building with concrete. First reinforced concrete is a very strong material. When built as shown in Figure 4-1, with poured concrete corner posts and a concrete structural bond beam, it is very resistant against wind and water forces. In fact this design is typical of American Samoa where wind speeds are often greater than 125 miles per hour. As further evidence of the strength, it is the type of building configuration (reinforced concrete moment frame) that makes the best emergency shelters identified in this report (see Part 3 on Evacuation Planning and Emergency Shelters and Figures 3-3 to 3-5).

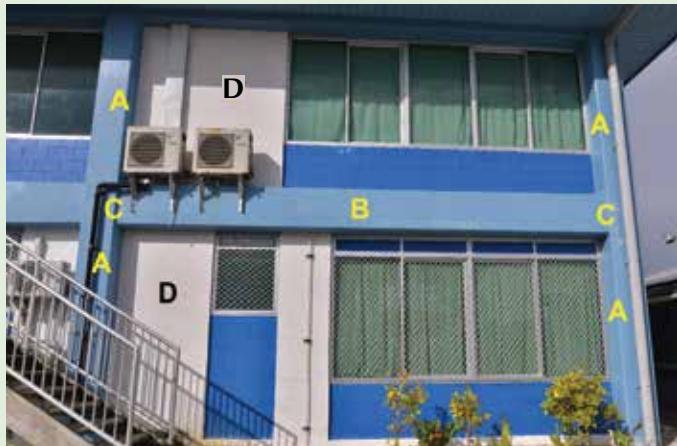
Figure 3-4. Many buildings identified as shelters have the Concrete Moment Frame – with columns (A), beams (B), and column-beam joints (C). They also have CMU blocks on the 1st and 2nd floors as infill (D) (see also Figure 4-39). While it is preferable that the first floor be open air as in Figure 3-3, this is still a strong structure if well maintained. This is the College Center at the CMI.

Examples of strong buildings with a Concrete Moment Frame and Concrete Masonry Unit (CMU) block infill are at the CMI (Administration Building, Learning Center and College Center only) (Figure 3-4), Rita Elementary School and the Marshall Islands High School. Many buildings in Majuro, including many residential houses are built with this design (see Part 4 of this book - Figures 4-1 to 4-3). However, houses cannot be used for shelter for a strong tsunami or typhoon because they lack elevation.

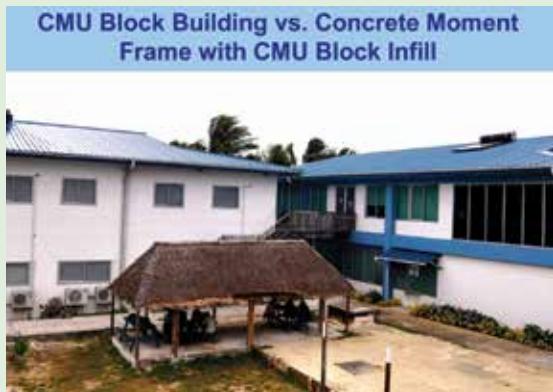
Figure 3-5. The building on the right has a Concrete Moment Frame as shown by the blue columns and beams and CMU block infill (Administration Building at CMI). Compare that with the building on the left with only CMU blocks (Tole Mour Hall at CMI). The building on the right is stronger because of the Concrete Moment Frame.

There are also buildings in the Marshall Islands with no Concrete Moment Frame and are CMU block infill (Figure 3-5).

Examples of buildings with just CMU block are Tole Mour Hall, Wapepe Hall, Debrum Hall and Rebbelip Hall at CMI (Figure 3-5). These buildings can be used as a shelter if well maintained although they are not as strong as the Administration and Student Center Buildings.

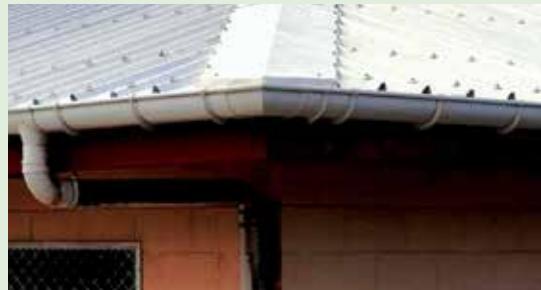
Figure 3-6. Marshall Islands High School has many of the criteria looked for in a shelter. Note corrugated metal roof with sufficient fasteners and large washers to hold the metal roofing down during high wind events. The fasteners should be ring-shank nails or screws that are well-embedded into the supporting roof trusses, rafters, or purlins.

winds during a typhoon. The structural factors required for a sound roof are: good condition roofing that is well attached to the roof framing members (Figure 3-6); strong roof trusses (Figure 3-7) or roof beams (Figure 3-8); and a strong connection of the roof framing to the supporting columns, beams, or walls of the building (Figure 3-9).

3. Tie down roofing	Secure roofing material to the roof (usually plywood over the trusses or rafters) with sufficient number of fasteners and large washers (Figure 3-6).

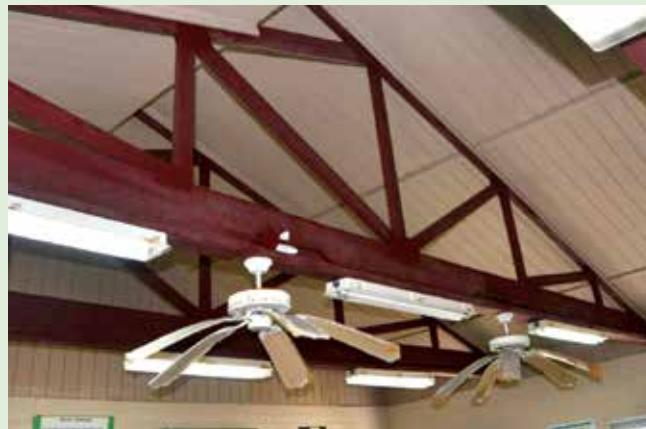
Figure 3-7. The roof trusses should be engineered and pre-manufactured. This will be standard in newer government buildings, especially schools. It will not be for older buildings. This photo shows a typical roof truss at Marshall Islands High School.

4. Roof framing tied down	The trusses should be pre-manufactured and engineered for uniformity and strength (Figure 3-7). Roof trusses must be bolted to the beams, columns or walls to prevent lift-off during high wind events (Figure 3-9). Alternatively, ridge beam, and large sloping rafters should be connected to walls, columns, or beams with steel metal connectors (Figure 3-8).

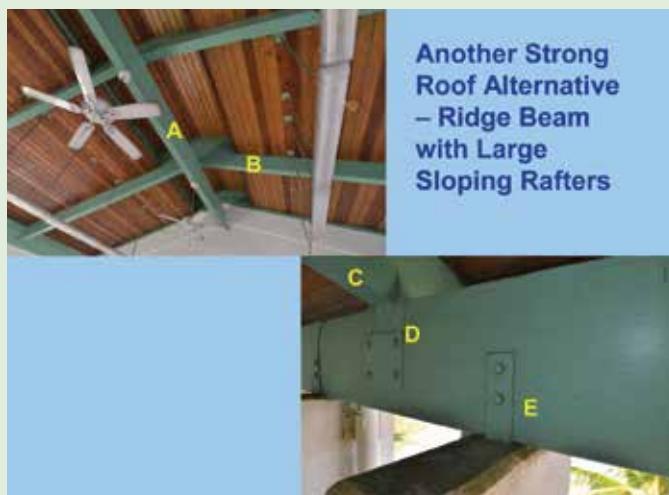
Figure 3-8. Another strong roof design is to have a ridge beam (A) attached with steel connectors to large sloping rafters (B) (top left photo). The sloping rafter (C) then connects to a horizontal beam (D) with a steel plate (bottom right photo). The beam is connected to the concrete column (E) with another steel connector. Photo from Marshall Islands Middle School.

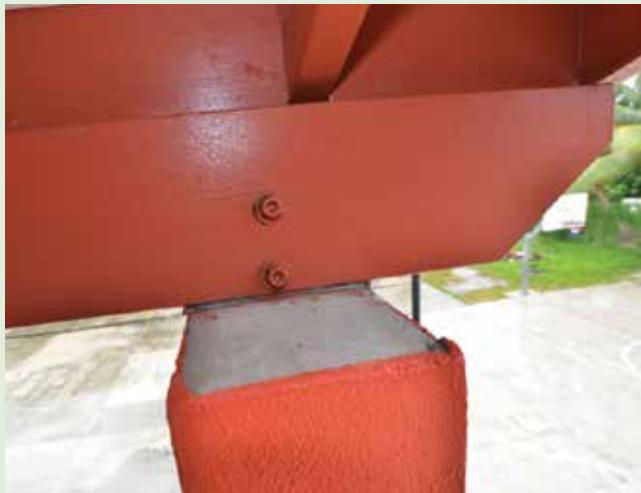
Figure 3-9. This roof truss is connected to the CMU column with a bolted plate to prevent roof uplift during strong winds. Connection of roof trusses to the walls, beams, or columns is also important for residential houses and is covered in Part 4.

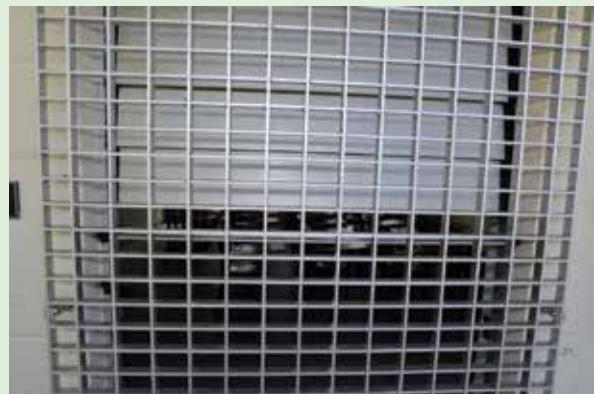
Figure 3-10. This screen at the Marshall Islands Middle School is made of strong aluminum bars in both directions and is attached to the CMU or concrete walls with embedded anchor bolts. The louver behind the screen can still be struck by small flying gravel, so should be made of shatterproof glass, glass with protective laminate, or aluminum slats for additional safety for those inside.

5. Window protection	Windows protected from debris impacts (Figures 3-10 and 3-11). Window behind screen should be shatterproof or laminated.	
6. Sturdy doors	The shelter doors should be made of metal or solid wood with quality latches and hinges to prevent their opening in high wind (Figure 3-12).

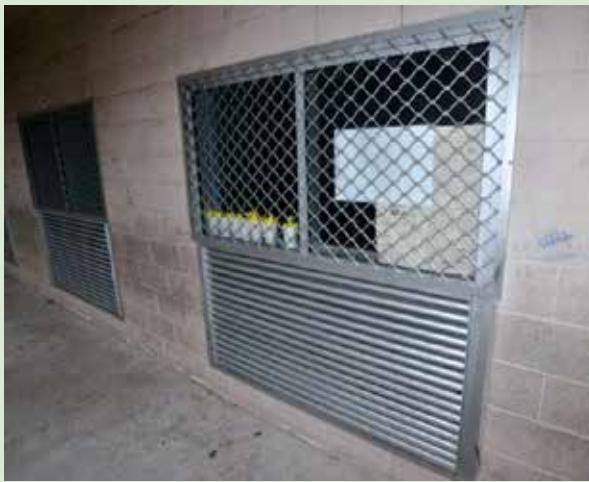
Figure 3-11. Security screen at Rita Elementary School helps to prevent breakage of the window by large debris. Behind the screen, the window should be shatterproof and/or a protective laminate added to the glass. Window protection is needed for any room that is a shelter on the second and third floors. All floors that are higher do not need window protection because the risk of wind-borne debris above 30 feet is less.

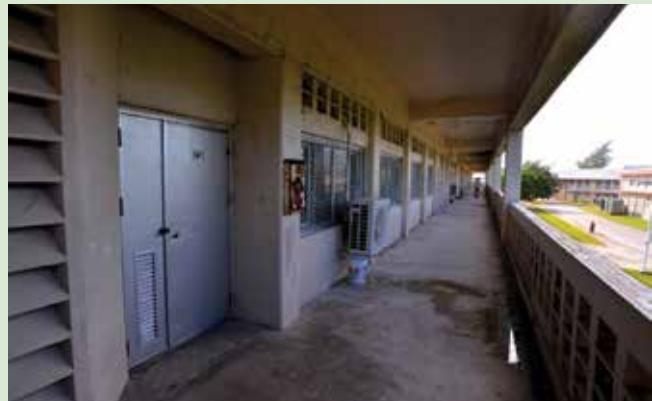
Figure 3-12. All exterior doors leading to the shelter areas should be sturdy metal or solid wood doors, with quality hinges and door latches to secure the shelter during high winds with potential debris impacts

During a typhoon there will be a lot of flying debris carried by high winds. It is important that this debris does not break any of the doors or windows at the shelter, otherwise wind will enter and add to the uplift pressure on the roof. It will also bring rain and flying debris into the shelter where it could injure occupants. Any room that is used for a shelter on the second and third floors must have a strong door and window protection so that wind, rain, and debris do not break through. Thus screens such as those shown in Figures 3-10 and 3-11 should be on all the second and third floor windows. The protection is not needed for the fourth floor and above because the wind-borne debris will not get that high up. Figure 3-12 shows a strong exterior metal door at the second floor of Marshall Islands High School.

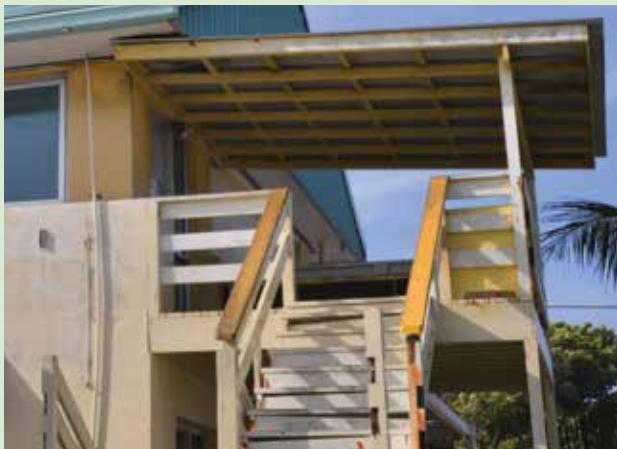
Figure 3-13. Some sturdy reinforced-concrete buildings have wood stairs to the second floor. They are likely to be damaged or washed away during heavy wave inundation. Such contingencies need to be planned for by having an emergency ladder readily accessible on the second floor. Note that the roof over this upper landing is also likely to be damaged or blown away during a typhoon. Photo of the Majuro Youth Center.

Other factors to consider when selecting a suitable shelter building relate to access to the shelter level (Figure 3-13), the condition or maintenance of the building (Figure 3-14) and access to restrooms and potable water (Figure 3-15).

7. Strong stairs	Some sturdy buildings have exterior wood stairs to second floor. These can be washed away during inundation events. Are there contingencies? (Figure 3-13)

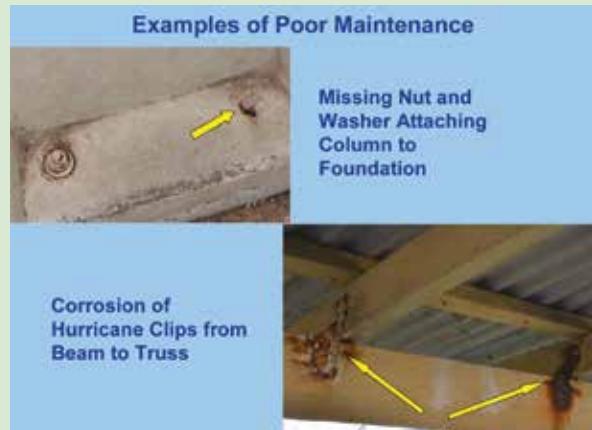
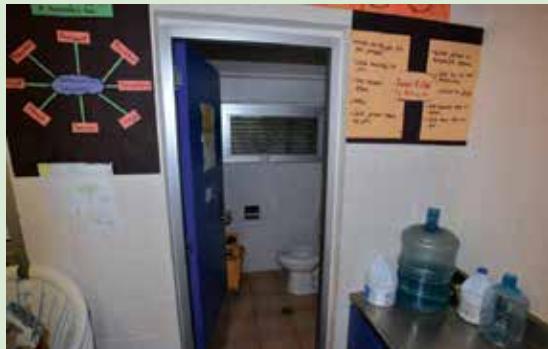
Figure 3-14. A potential shelter must be properly maintained. Here are examples of maintenance issues which could weaken the structure. Top left – missing washer and nut attaching waffle-crete column to the foundation. Bottom right – corrosion of hurricane clips attaching roof trusses to beam. As buildings get older, maintenance becomes a bigger issue.

8. Well maintained	Look for newer building (under 20 years for CMU construction), no corrosion of fasteners, and no missing connections (Figure 3-14).

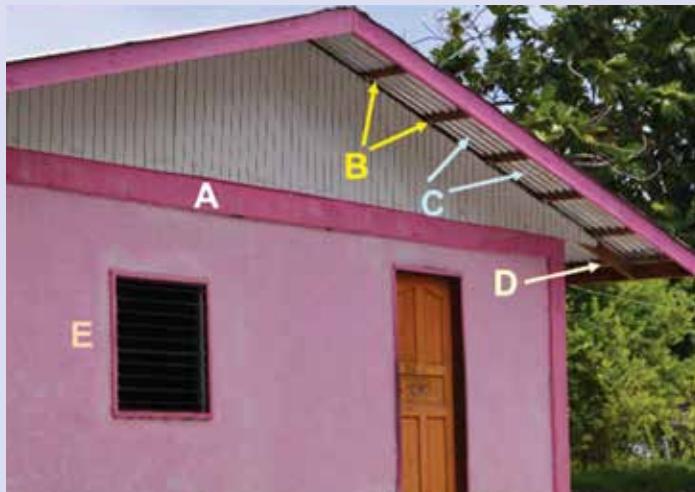
Figure 4-1. Common parts of a Marshallese home from the outside. (A) Concrete structural bond beam. (B) Purlins typically run parallel to the length of house and are 2 inch by 3 inch lumber. (C) Aluminum or steel corrugated metal roofing. (D) Trusses typically running parallel to the width of house and consist of 2 inch by 6 inch lumber. (E) Windows and doors typically framed by 2 inch by 4 inch lumber.

A typical house in the Marshall Islands has concrete walls that are fairly strong against wind forces. As was discussed in Part 3, and shown in Figure 4-1, the houses commonly have a moment frame consisting of concrete poured corners and a structural bond beam. The weak link is often the attachment of the roof to the concrete walls. Thus many of the options given deal with strengthening the entire roof structure.

Let's begin with some terminology for existing houses beginning in Figures 4-1 to 4-3.

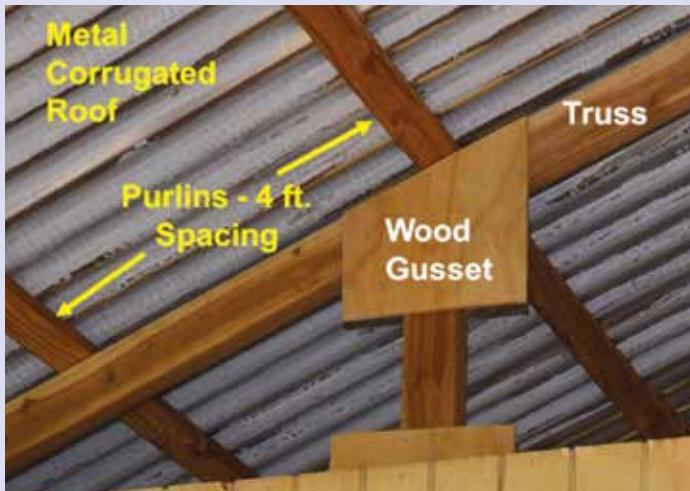
Figure 4-2. As shown in Figure 4-1, the trusses typically run parallel to the width of the house and are made of 2 inch by 6 inch lumber. On top are purlins, consisting of 2 inch by 3 inch lumber, typically running parallel to the length of the house. Attached to the purlins is the metal corrugated roof.

For a strong roof and house against the wind and rain there must be a strong connection or tie from the: (a) wood top plate to the concrete structural bond beam (Figure 4-3); (b) trusses to the wood top plate (Figure 4-3); (c) purlins to the trusses (Figure 4-2); and (4) metal corrugated roof to the purlins (Figure 4-2). It is possible, depending on access, for existing houses to be retrofitted so that some or all of these connections are strengthened. This is covered in Figures 4-4 to 4-27. These connections can be considered for existing homes in a retrofit application, depending on feasibility (access, cost, etc.). They should definitely be considered during new construction, when access is not a problem.

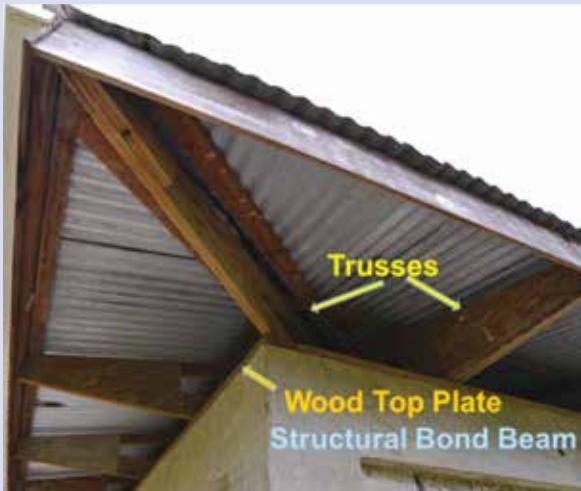
Figure 4-3. On top of the concrete structural bond beam is commonly a wood top plate, consisting of 2 inch by 4 inch lumber. On top of the wood plate are the trusses. To prevent wind damage during a storm, there must be a strong connection from: (a) the wood top plate to the structural bond beam; (b) the trusses to the wood top plate; (c) purlins to the trusses; and (d) metal corrugated roof to the purlins.

Even if wood is sitting on masonry (for example, a wooden sill plate on a concrete foundation - similar to a wood plate in Figure 4-3), but on the foundation and usually transitioning to wood framing, this may be too close to the ground and extra protection may be in order. The extra protection is often in the form of using treated lumber. Some articles suggest keeping wood sills and foundation walls at least 8 inches above grade.

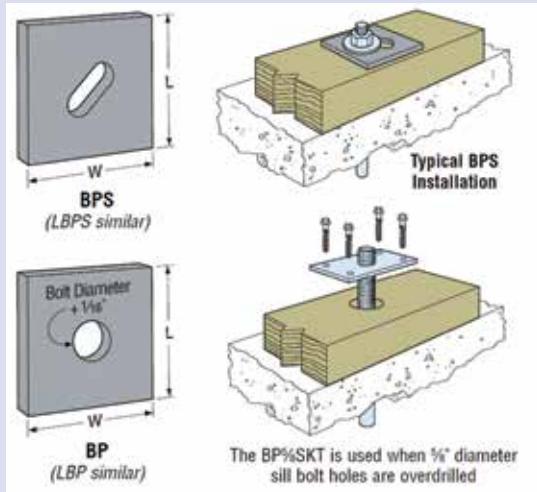
Figure 4-4. Typically, there is a 2 inch wood top plate over the concrete structural bond beam. In new installations and possibly in retrofit applications, a metal bearing plate should tie the wood plate to the concrete beam. Bearing plates and load bearing plates that are on Page 40 of the 2015-2016 Simpson Strong-Tie Wood Construction Connectors Catalogue (SWCCC) can be used (see: <http://www.strongtie.com/literature/c-c-2015.html?source=halfblock>). The bolts are embedded in the concrete at the time the wall is poured.
