HOMEOWNER'S HANDBOOK TO PREPARE FOR NATURAL HAZARDS

REPUBLIC OF THE MARSHALL ISLANDS

By
Don Hess
Dennis Hwang
Karl Fellenius
Ian Robertson
Mark Stege
Ben Chutaro

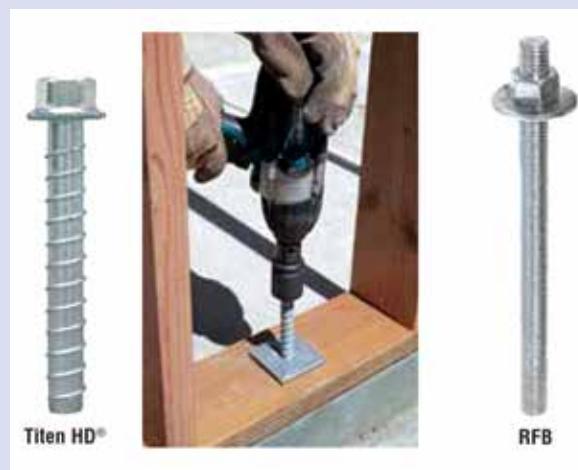
Figure 4-5. For retrofit of existing structures, where a strong connection between the wood top plate and concrete structural bond beam is needed, sill plate anchors such as on page 42 of the SWCCC can be used. Bearing plates can also be used. This retrofit requires sufficient access under the roof. A right angled impact driver may be needed. For the screw on the left (Titen HD), pre-drill the hole to the size of the shaft, with a hammer drill using a concrete bit. Then screw in with an impact drill. For the fastener to the right, drill with a 1/8 inch oversized hole, then fill in with structural epoxy.

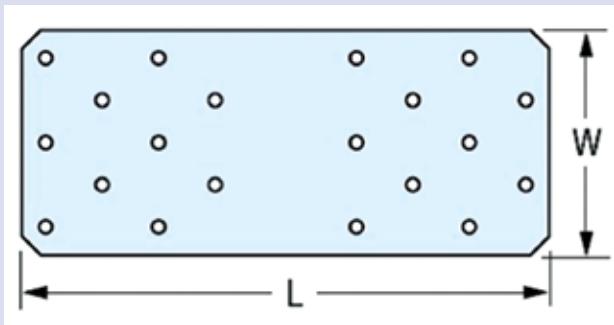
Figure 4-6. Another way to tie the wood plate to the concrete beam is to use the HTP37Z Metal Plate. This plate is 7 inches long and 3 inches wide. Five of the 1 1/2 inch long 10d nails attach to the wood (see Table 4-1) and page 22 of the SWCCC. For the concrete, use five masonry screws such as a Titen Hex Head on page 173 of the SWCCC in order to match the loads. In installation, the plate is oriented with the long axis vertical. To use this, either the interior or exterior of the wood plate and wall must be flush.

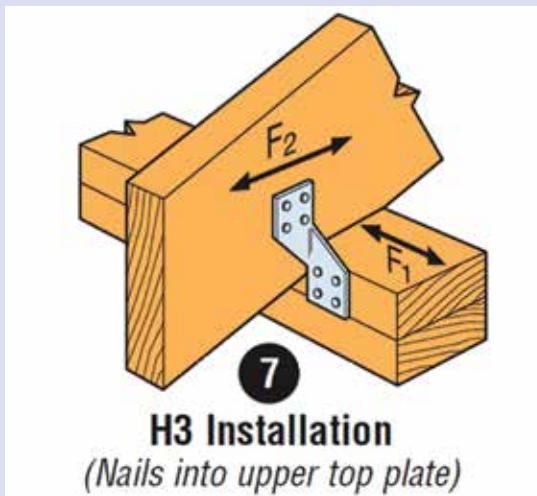
Figure 4-7. To tie the Truss to the Wood Plate, H3 clips are very useful. The H3 allows 455 lbs of upload resistance per Truss. It is useful when there is only one wood plate on top of the concrete wall (see Figure 4-3). Four 8d Common nails go into the truss and four into the one wood plate. **The H3 clip is inexpensive, readily available in Majuro and suitable for retrofit applications.** For other methods to tie the truss to the wood plates or wall (see Figures 4-8 to 4-14). The advantage of the H3 clip is that it provides an engineered solution to resist high winds.

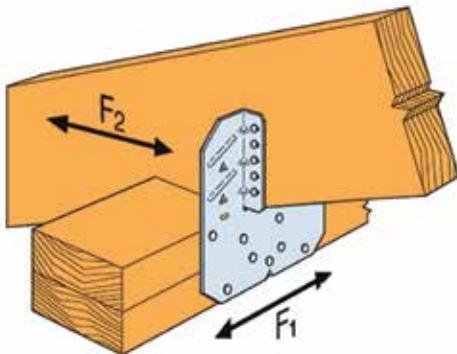
20 H10A Installation

Figure 4-8. Sometimes there are two wood plates over the concrete beam. In this case the H10A clip can be used. This tie offers more than twice the uplift protection compared to the H3. Follow the nailing pattern on page 196 and 197 of the SWCCC catalogue. Nine 10d by 1½ inch nails are in the truss and nine 10d by 1½ inch nails are in the wood plates. The Homeowner has the choice to use the easier to install, and less expensive H3 or the H10A, which offers more protection. Either the H3 or H10A can be used in new or retrofit applications, depending if there is access.

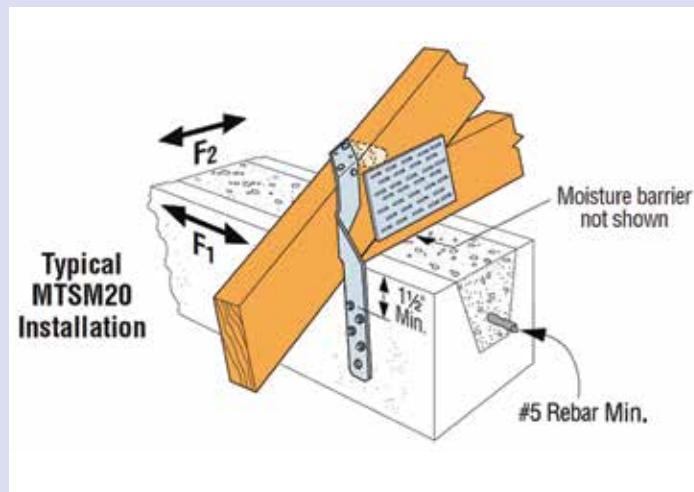
Figure 4-9. For new installations, the MTSM/HTSM strap offers 860 to 1175 pounds of uplift protection per truss and is suited when there is no wood plate and the connection is from the truss to the concrete wall. This can be found on page 182 of the SWCCC. Masonry screws – 4 quarter inch wide and 1¾ inch long go into the concrete and seven 10d nails go into the wood truss.

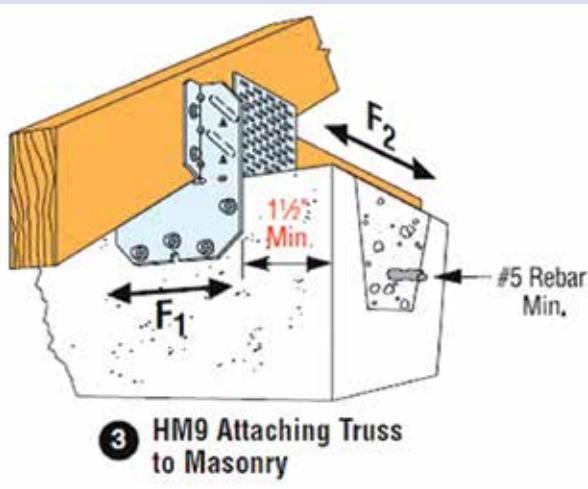
Figure 4-10. The HM9 is a connector made especially for the situation where there is no top wood plate and the attachment is directly from the truss to the concrete structural bond beam. This is good for retrofit applications and requires 4 of the SDS ¼ inch wide and 1 ½ inch long screws for the truss and 5 of the ¼ inch wide by 1 ¾ inch Titen screws for the concrete. See page 178 and 179 of the SWCCC.

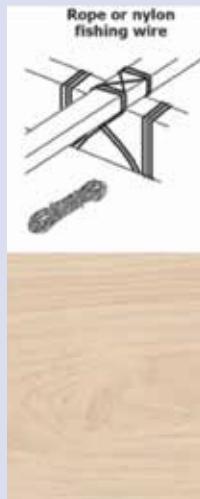
Figure 4-11. Tying roof members to post with coconut fiber rope. This is a traditional Marshallese way of tying roof members to the supporting beams. It is stronger than just toenailing wood members, which can be easily pulled apart in tension by high winds. Image in top-left corner from Sheltercluster.org.

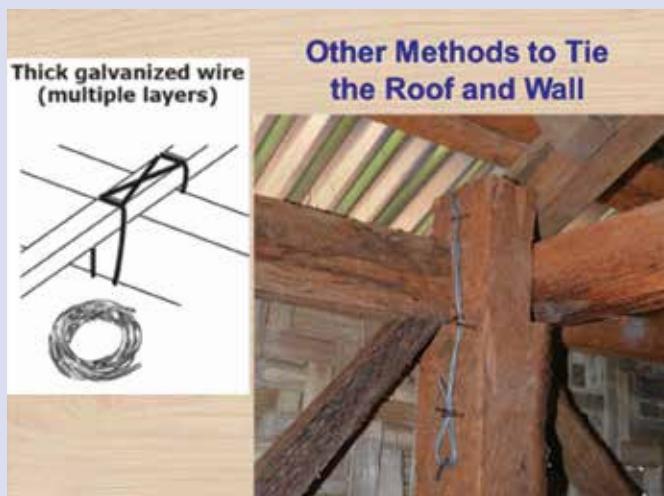
Figure 4-12. Attaching roof members to a beam with multiple layers of galvanized wire. Image in top-left corner from Sheltercluster.org.

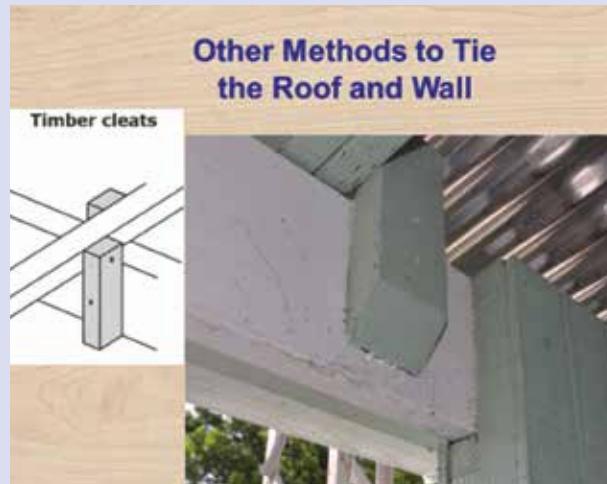
Figure 4-13. Attaching truss to beam with timber cleats. The cleats are ground contact, termite treated 2 by 4's made of Douglas fir. 8 inch pieces are beveled at the end for aesthetics and painted with 2 coats of indoor/outdoor primer and 1 coat of paint to match the wall. Three – 3 inch screws attach the cleat to the white beam. Three – 3 inch screws from the opposite side of the truss attach it to the cleat. The process is repeated if two cleats are used per truss. Photos courtesy of Ben Chataro. Image in top-left corner from Sheltercluster.org.

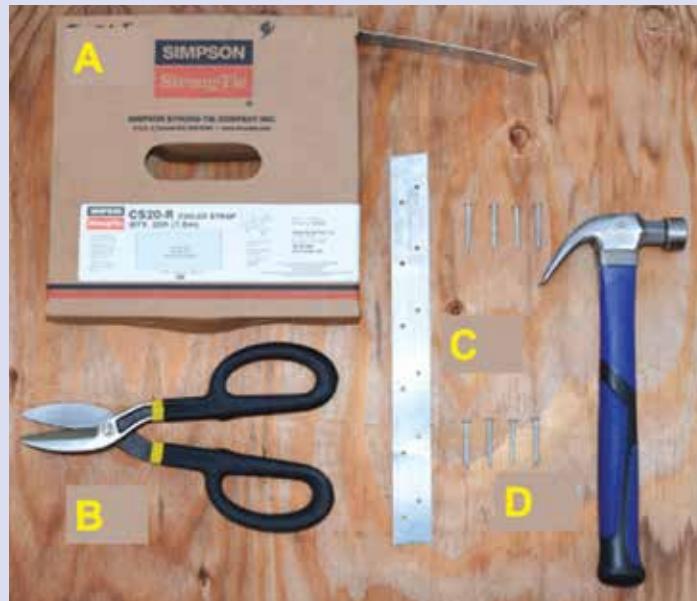
Figure 4-14. Attaching roof members to the beam with galvanized metal straps. (A) Structural straps in a coil and with different lengths and thickness are available locally. (B) The strap is cut to the desired length with a metal snippet. (C) Metal strap cut to desired length. (D) Six 10d or seven 8d common nails can be used to attach each end (page 189). The length is cut as needed, or the table in SWCCC can be followed for specific design loads. This is a general purpose connector for members that are flush. For those at right angles to each other, bends may be needed, and thus other connectors may be more useful. The advantage of the coiled straps is low cost and the flexibility to adjust the length. CS-16 straps are available in Majuro at a cost of \$138 for a coil of 150 feet.

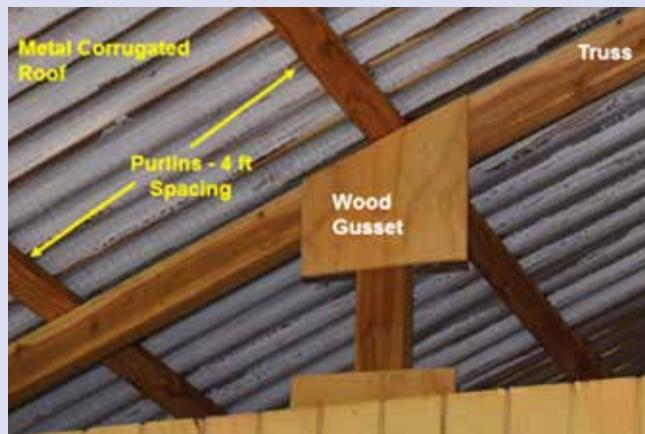
Figure 4-15. Typical roof structure can be strengthened for new construction and in retrofit applications. To tie the roof trusses, sometimes nails are used in tension, which pull out easily in high winds. Stronger is the use of wood gussets, instead of nails to tie the truss together in shear. Note the purlins are spaced 4 feet apart. If the purlins were 2 feet apart the roof would be stronger.

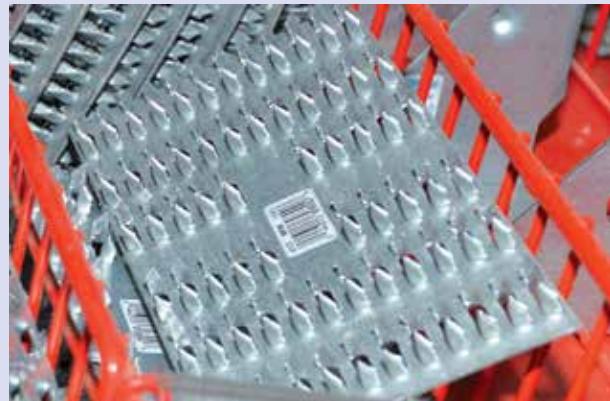
Figure 4-16. Strong truss connections come from the use of metal plates or wood gussets. Both the metal plates and/or wood gussets can be used for new construction or could be used for retrofit applications if the roof structure is not covered by a ceiling. Mending plates are readily available at the hardware stores in Majuro. They come in different sizes so make sure they are designed for trusses.

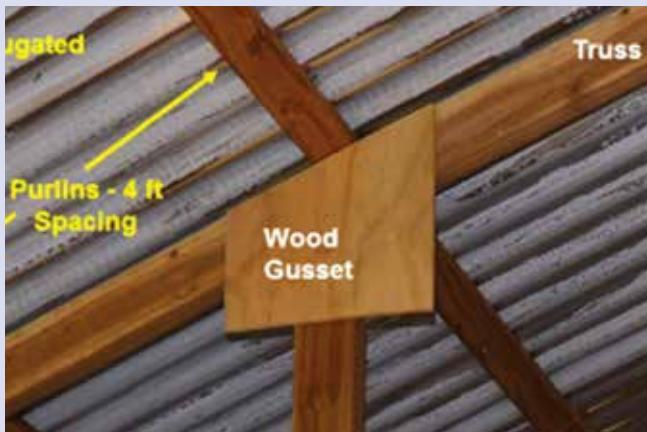
Figure 4-17. In an enlargement of Figure 4-15, on top of the trusses, are wood purlins (2 by 3's) running perpendicular to the trusses and parallel to the length of the house. The metal corrugated roof is attached to the purlins. It is important that the purlins are strongly fastened to the trusses. This can be done for new buildings and in retrofit, if a ceiling does not cover the roof structure.

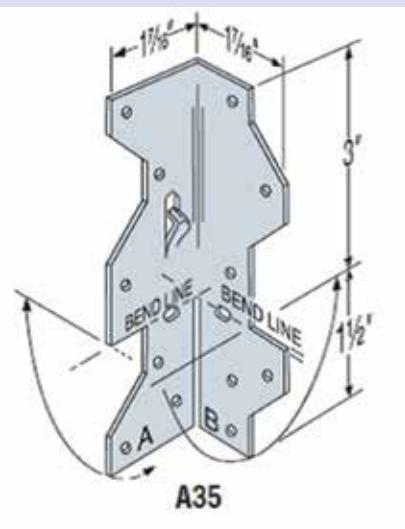
Figure 4-18. The A35 clip can be used to fasten wood at right angles, such as for the truss-purlin connection. The A35 plate pictured here and on page 206 of the SWCCC has bend slots which allow instant, accurate field bends for all two- and three-way ties. The reversible design permits the A35 to secure a great variety of connections. Nine 8d 1.5 inch nails are used to make the connection. The clip is readily available in Majuro. It is important that similar metals be used. For example, use stainless steel nails for stainless steel A35 clips. Use hot dipped galvanized nails with hot dipped galvanized A35 clips. Do not mix the metals for the clip and fastener.

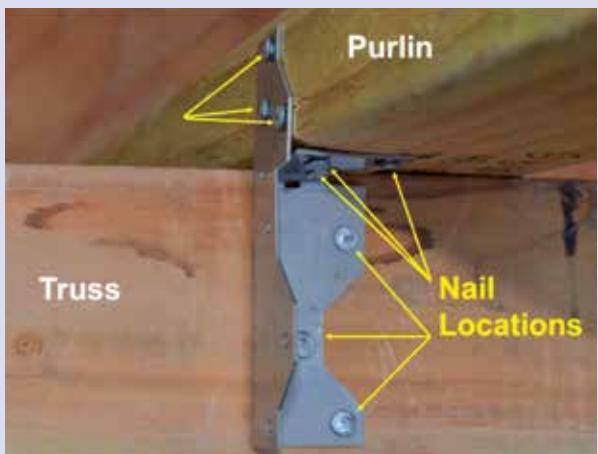
Figure 4-19. The A35 plate can strengthen the connection between the truss and purlin. This Figure shows how the A35 clip can be configured. The A35 clip is bent so that one tab and 3 of the 8d 1.5 inch nails are on the side and bottom of the purlin. Another tab with the similar fastener configuration is in the truss.

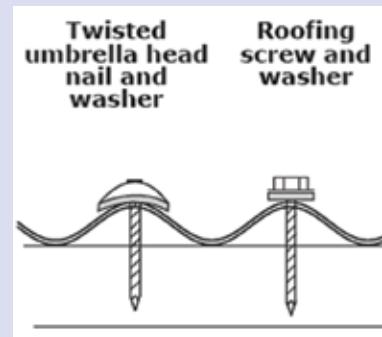
Figure 4-20. Typically corrugated metal roofing is attached to the purlins with nails. Even stronger is to use a twisted umbrella head nail and rubber washer. These are made in New Zealand. This is the connection recommended by Sheltercluster.org for their manual in the reconstruction of the Philippines after Typhoon Haiyan/Yolanda. Alternatively, a roofing screw with washer can be used. These fasteners can be used for: (i) new roofs, (ii) the retrofit of existing roofs, if the current roof is damaged, or (iii) as additional fasteners on an existing roof. For any screw or nail, the material for the fastener and the roof needs to be the same. For example, use aluminum screws to attach the aluminum roof to the purlins.

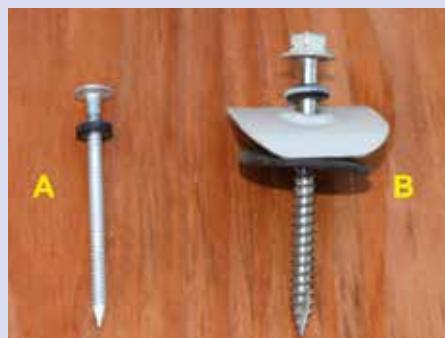
Figure 4-21. Different fasteners to tie the metal corrugated roof to the Purlins. (A) Aluminum ring shank nail with rubber washer is a strong method to attach the aluminum roof. Material is readily available in Majuro. (B) Aluminum screw with rubber washer, aluminum metal cap and another rubber washer is an even stronger method to tie the metal roof to the purlins. Unit cost is about \$1. The Majuro Department of Public Works ordered these in bulk to attach the roofs for the local schools.

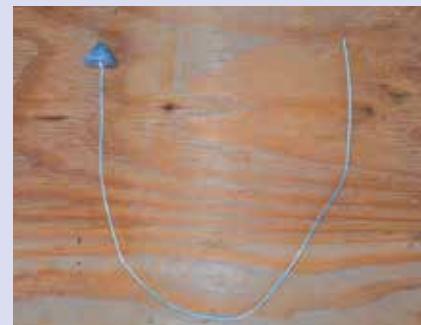
Figure 4-22. Roof ties with a metal wire are an inexpensive but strong method of attachment. The ties are about 50 cents for 12 and consist of a metal cap with G1 wire. Once a hole is drilled in the roof, the wire is threaded through the hole and wrapped around a screw or nail that is attached to the purlins. The screws or nails are perpendicular to the potential uplift wind forces, as opposed to being parallel, when they can more easily be pulled out. Photo courtesy of Ministry of Public Works.

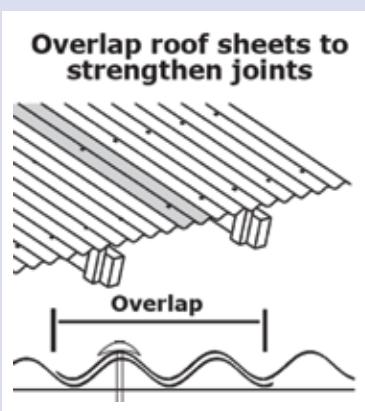
Figure 4-23. Additional measures to strengthen the roof include providing sufficient overlap of the corrugated metal sheets in order to strengthen joints (From sheltercluster.org). It is recommended that there be at least two ridges overlap. This should be done for new construction and in the repair or replacement of existing roofs.

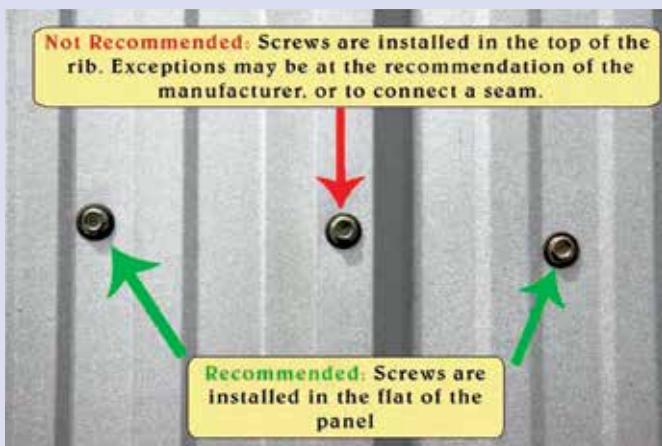
Figure 4-24. Some roofs in Majuro have flat sections that differ from undulating roof sheets shown in Figures 4-20 and 4-23. In this case, fasteners to the purlins should be in the flat lower flat portion of the panel. Photo courtesy of Christian Oakes, IOM.

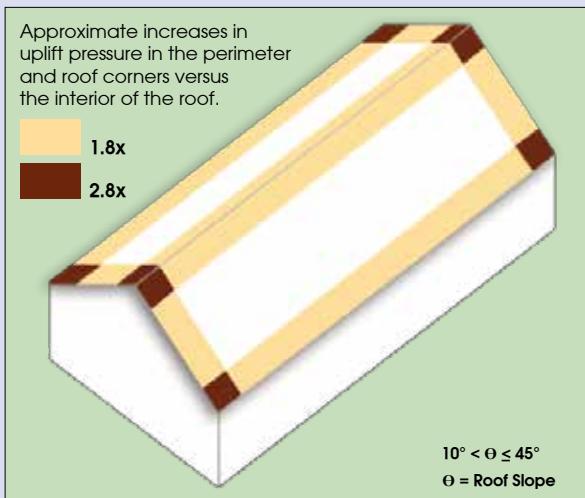
Figure 4-25. For high wind events such as a typhoon, uplift pressure to blow the roof off will be greatest at the corners, roof edges and ridges. At the corners it may be 2.8 times greater. At the edges and ridges, 1.8 times greater (from Homeowner's Handbook to Prepare for Natural Hazards – Hawai'i). For this reason, use more nails or preferably screws in these areas.

Figure 4-26. Due to greater uplift pressure on the roof edges and ridges as shown in Figure 4-25, more nails, or better yet, screws should be used to fasten the roof to the purlins at the roof edges and ridges. In addition, note the purlins are 2 feet apart to create a stronger roof (from Sheltercluster.org). This differs from the typical 4 feet spacing in the Marshall Islands.

Figure 4-27. Uplift pressure on the edges and corners of the roof is greatest (see Figure 4-25) due to overhangs. Limit the overhangs to 45 cm or 1.5 feet maximum (from Sheltercluster.org). This can be done in new design, or when roofs are repaired or replaced as a retrofit. It is very important to have the proper connections from the roof to the purlins (Figures 4-20 to 4-24) and limit overhangs. Without proper precautions, the roof can easily peel off in high winds. Providing plywood to cover the bottom of the rafter extensions will also reduce the uplift load on the roof sheeting.

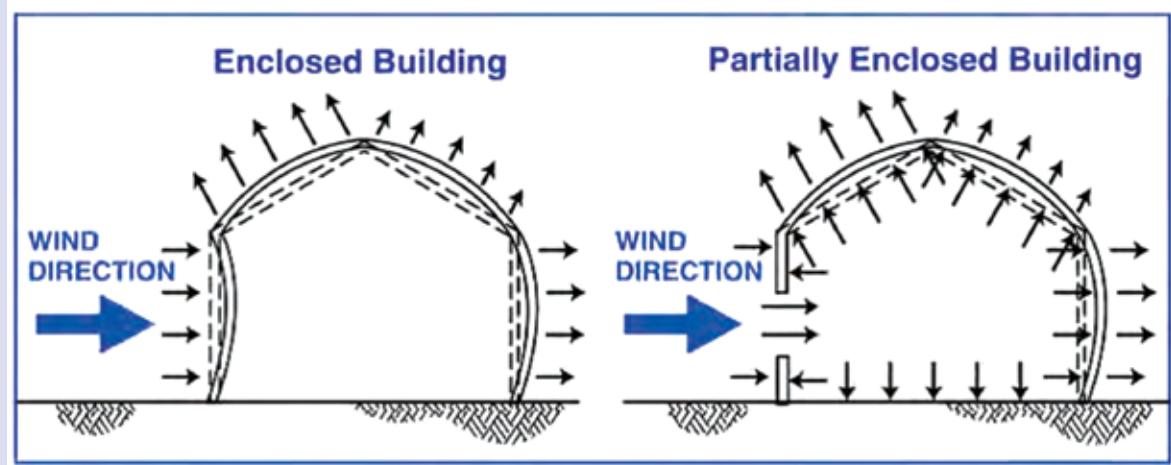
Figure 4-28. The house on the left has no openings. There is external pressure from the wind on the walls and roof only. The house on the right has an opening, either by design or because a window broke. Now there is external and internal wind pressure on the walls and roof, making it more likely for the roof to fly off. See Figure 2-6 for typical wind damage in the Marshall Islands from a typhoon, with roof blown off. This is why it is important to protect the windows with a covering such as plywood during a typhoon (see Figures 4-29 and 4-30).

During a typhoon, no wind or rain should penetrate the envelope of the house (see Figure 4-28). If a window breaks, it allows the wind to enter the house and cause internal pressure that increases the uplift on the roof. Thus it is important to protect windows with a shutter, most commonly plywood.

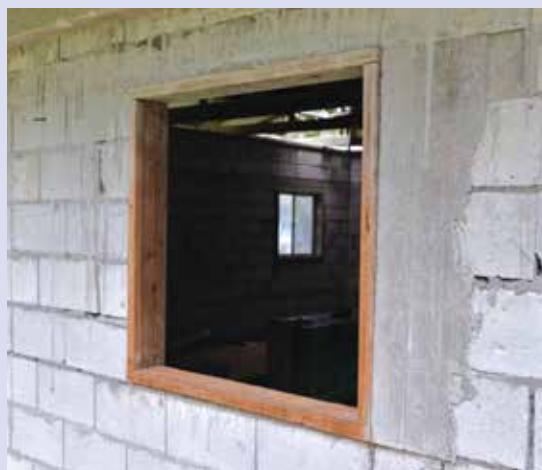
Figure 4-29. Typical window for a concrete house in Majuro has the window framed by 2 inch by 4 inch, or 2 inch by 6 inch termite treated lumber. If the window framing and concrete wall are flush, plywood can be cut to overlap the treated framing lumber by 1 or 2 inches. Then fastener holes can be pre-drilled in the plywood at a pre-determined spacing to hit the middle of the 2 inch by 4 inch or 2 inch by 6 inch, while staying away from the edge of the plywood. If the window framing is inset, the plywood must be precisely cut to insert in the inset. Fastener holes should still be pre-drilled into the plywood.

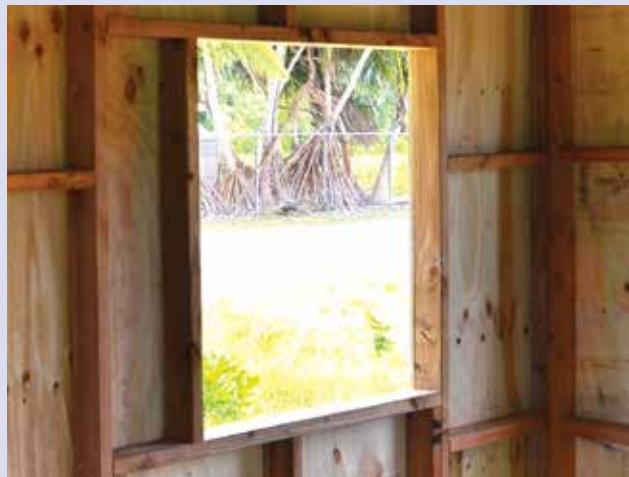
Figure 4-30. For this wood framed house in Majuro, the 2 inch by 4 inch or 2 inch by 1 inch 6 inch lumber frames the window, as in Figure 4-29. Plywood panels should be pre-cut to the proper size to overlap the window. The fasteners must go into the framing lumber (2 inch by 4 inch or 2 inch by 1 inch 6 inch) not the wood panels covering the side of the house. Follow the 4 P's (Figure 4-31) and suggestions below.

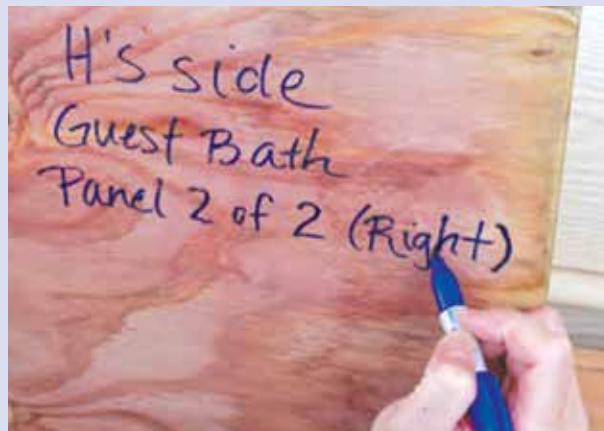
Figure 4-31. Remember the 4 P's in preparing plywood shutters. (1) Precut the plywood to the proper dimensions before an event; (2) Prelabel the plywood for the appropriate window; (3) premark the location of the fasteners on the plywood; and (4) Predrill the faster holes on the plywood. All this preparation needs to be done in advance, and generally cannot be done if there is an incoming typhoon.

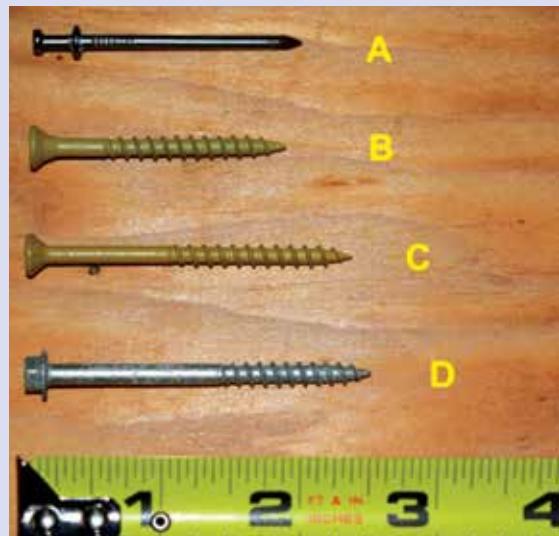
Figure 4-32. Fasteners that can be used to attach plywood storm panels. A) Duplex or two-headed 2 inch nails are used to initially attach the top left and right corners of the panel to the wood framing of the window. B) #8—2 inch wood driving screw. Allows $1\frac{1}{4}$ inch embedment; C) #9—2.5 inch wood driving screw. Allows $1\frac{3}{4}$ inch embedment; D) #10 Lag Screw—in this case, a 2.5 inch Simpson self-driving screw. Not all lag screws are self drilling (see Tables 4-2 and 4-3).

5. Duplex nails can be used to attach the upper corners of a plywood panel to the window framing – then 2 inch screws can be used to fasten the panels (Figure 4-32).

Fastener Size	Thread Diameter (see Figure 4-32)	Pre-Drill Bit
No. 6 Wood Screws	0.138 inches or about 9/64 of an inch	7/64
No. 8 Wood Screws	0.164 inches or about 10/64 of an inch	8/64
No. 9 Wood Screws	0.172 inches or about 11/64 of an inch	9/64
No. 10 Wood Screws	0.190 inches or about 12/64 of an inch	10/64

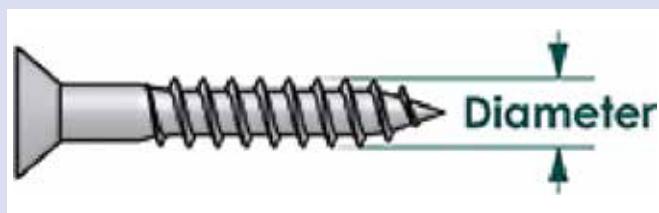
Figure 4-33. Wood screw numbers are based on the thread diameter as shown. A given number screw will have the same diameter but can have different lengths. For most plywood applications in the Marshalls, two inch long No. 6 or No. 8 screws will suffice. The key is to have at least 1½ inch penetration into the wood framing the window (see Tip 7). As noted previously, it may be difficult to find #6 Wood Screws with sufficient length.

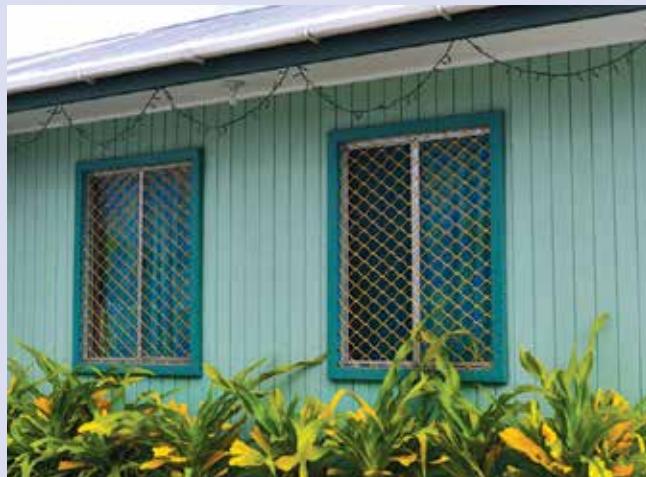
Figure 4-34. Many schools in Majuro and a few houses have security screening. The advantage of the screening is that it is always on the window. The disadvantage is that small stones or debris can still penetrate the screening if the holes are sufficiently large and break the window, thus allowing in rain and wind. Security screens need to be securely fastened to the framing of the windows.

If the homeowner does not want to prepare and store plywood, another option is security screening, which can serve the dual purpose of providing security, while preventing breakage of windows from flying debris (see Figures 4-34 and 4-35).

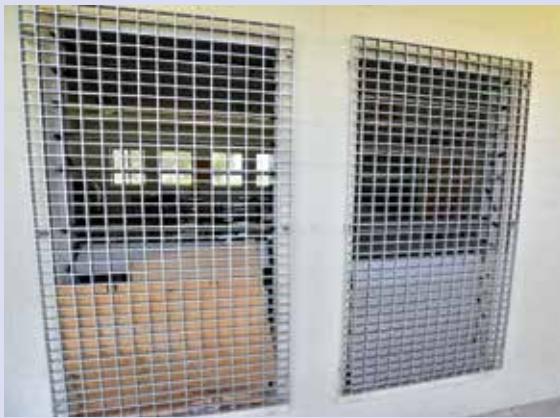
Figure 4-35. Another option for window protection is this aluminum security screen seen on a few schools such as Marshall Islands Middle School. The screen allows in light, and the openings are sufficiently small to stop most debris. The framing is bolted into the concrete masonry unit wall. While stronger than the screen in Figure 4-34, it is also more expensive. This is good window protection for houses with CMU walls (see Figure 4-1).

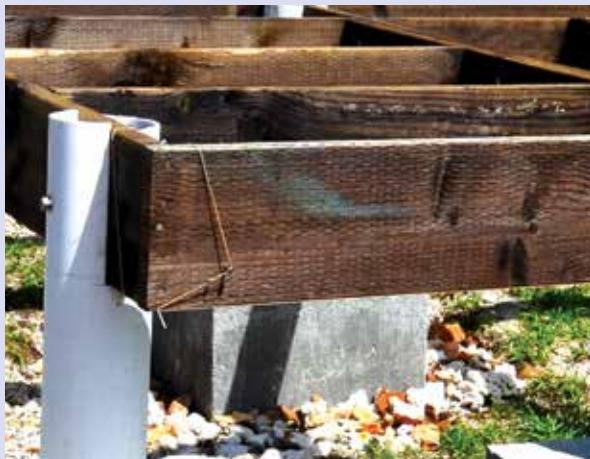
Figure 4-36. Example of ACZA wood suitable for use in the marine environment. Note the cuts or incisions on the surface to increase penetration of the chemical treatment. Because the chemicals in this wood are very corrosive, as well as the marine environment itself, stainless steel fasteners are used to attach the column to the wood joists (support for the flooring). Photo courtesy of Ben Chutaro.

Ammoniacal Copper Zinc Arsenate (ACZA) Wood. Generally wood with arsenic has been phased out of residential construction. However, it can be found for commercial settings and exterior use. ACZA is resistant to leaching and thus suitable for waterborne systems (Figure 4-36). It is very resistant to termites, but also very corrosive. It is suitable for the treatment of hard woods such as Douglas Fir.

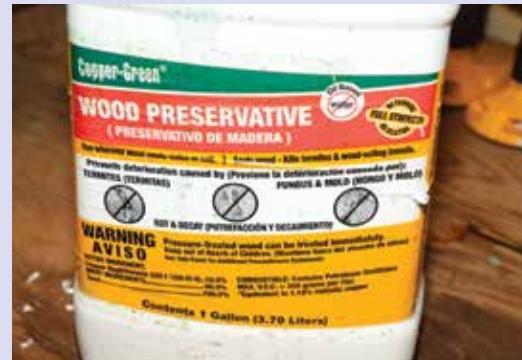
Figure 4-37. If you cut treated wood, the untreated interior may now be exposed to termites. Treat the exposed cut with Copper-Green, or another product which can be used to prevent termite damage, rot, decay, fungus, and mold. Ask your local hardware store for a suitable product.

- Treat wood that has been cut in the field (see Figure 4-37).
- Also ask assistants at your local hardware store about lumber.

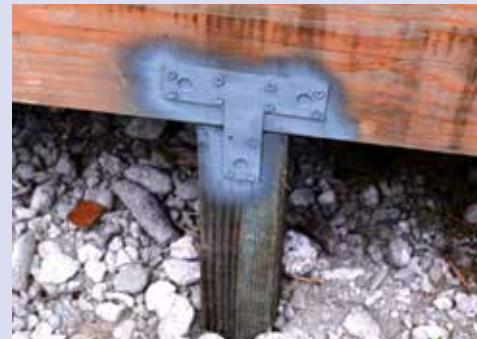
Figure 4-38. While it is a good practice to elevate the structure to reduce the chance of flooding, there is risk in putting a wood pier in direct contact with the ground. Treated wood can be subject to rot from wet or moist conditions. Leaching of the wood chemicals by water can expose the wood to termite risk. These impacts can be mitigated with the type of treated wood, or surrounding the pier with crushed rock or cement.

Prevent Contact Between the Ground and Wood/Lumber. It is preferable to never let wood products be in contact with the ground. For those thinking of elevating a structure for flood protection, caution should be taken if wooden posts are buried into the ground (Figure 4-38). Even treated wood in contact with the ground can be exposed to termites due to wood rot, or leaching of protective chemicals over time.

Although the method of elevation in 4-38 may be feasible, the preferred method for elevation is shown in Section 4.4.2 and Figures 4-41, 4-42, 4-43, 4-45, and 4-48. However, in cases where there may be lack of materials, such as no available aggregate or concrete, or there is limited funding for construction, the use of wood piers may come into play. In this case, the use of ACQ wood, or one with a higher concentration treatment such as ACZA should be considered to reduce termite risk. Termite risk can also be reduced by encasing the pier in crushed rock or a cement base.

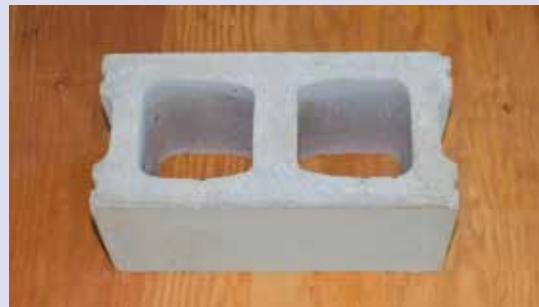
Figure 4-39. CMU blocks are the building blocks for many houses, commercial and government buildings in the Marshall Islands. Sometimes, the holes are left empty, and then the CMU is ungrouted. Other times they add rebar and concrete in the two holes making the CMU grouted and reinforced. Whether grouted or not, CMU blocks are a highly flood resistant material.

Concrete Blocks - Concrete Masonry Unit (CMU) blocks can be used for walls (Figure 4-39).

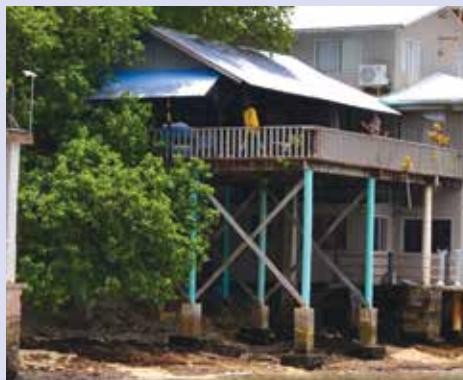
Figure 4-40. This house in Majuro was elevated to prevent damage from wave inundation and flooding. This is an extreme example of elevation of structures. Many houses in Majuro have been elevated a more modest amount (see Figure 4-41). This house has a spread concrete footing (see Figure 4-42). The brown wood members forming the X pattern are cross bracing to provide additional lateral support of the structure.

In Majuro, houses have been elevated from a few feet to over 10 feet to avoid flood and wave inundation damage. (Figures 4-40 and 4-41). Elevation is a time tested effective way to prevent property damage from coastal hazards **if designed and planned for properly**. The practice of elevation is an option for new houses and is generally not feasible for existing structures. Because it is primarily for new houses, only a few design suggestions are in this section for consideration by homeowners and government officials contemplating the more formal use of this option.

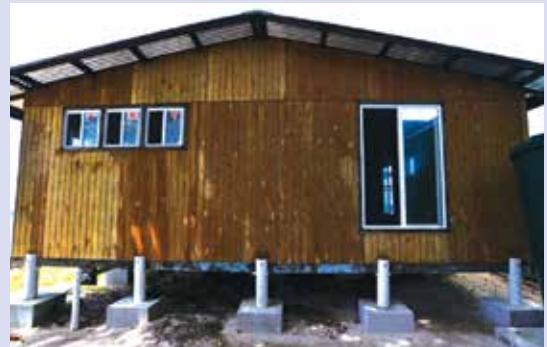
Figure 4-41. Another house in Majuro was elevated about 3 feet above grade. A spread concrete footing (Figure 4-42) was utilized with concrete piers encased in PVC pipe. The piers extend into the footing and are reinforced with epoxy coated rebar. Photo courtesy of Ben Chutaro.

Compare the houses in Figures 4-41, 4-45, and 4-48. These are just three different designs. But there are many ways to elevate a structure (see also Figure 4-38). Note with increased strength, comes increased costs. These are the tradeoffs. Someone building a new home can choose from the different designs, depending on their budget. Modification of the different designs is also possible to make them stronger and more expensive or cheaper. For example, it is possible to build the CMU piers in Figure 4-45 with epoxy coated rebar (Figure 4-47), grout the CMU (Figure 4-39), and bury the piers (Figure 4-42), which would add cost but be stronger. It is possible to build the house in Figure 4-41 higher, with wider piers, or ones that are more closely spaced, also adding strength and cost. Conversely, it is possible to reduce cost in Figure 4-48 by making a smaller, less elaborate structure. Thus there are many design variations of the three options provided, as well as other design concepts which are not covered in detail because the major emphasis of this book is retrofit of existing structures versus the design of new structures.

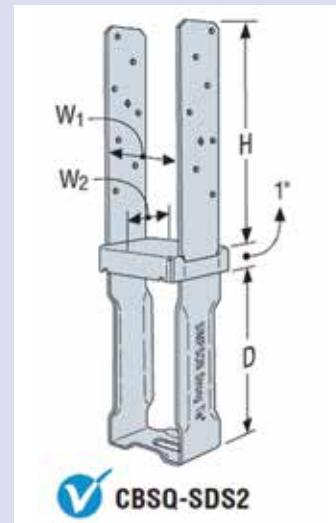
Figure 4-42. Example of a spread footing for a pier or column that could be used to elevate a house. The spread footing is wider at the base than at the surface. Typical design issues are the depth of burial, width of the column, and spacing between columns. In the Marshall Islands, because of the shallow water table, and the common presence of a hard reef rock underneath, the depth of burial is often limited. Too shallow a burial can lead to failure. In this example a wood column is attached to the concrete spread footing with a steel strap (Figure 4-43). The connecting steel strap provides a gap between the two materials. Figure courtesy of Sheltercluster.org.

- For any elevation scenario an experienced and qualified coastal engineer and architect should be consulted, if available.
- Piers or columns to elevate are generally made of wood or concrete. In the Marshall Islands, wood should generally not be used because of the issues with termites and water rot. If wood is used, it should not be for the portion in contact with the ground (see Figures 4-42 and 4-43). If cost is an issue, special precautions may be needed (see Figure 4-38).
- An effective pier or column should have a spread footing at the base (see Figure 4-42).

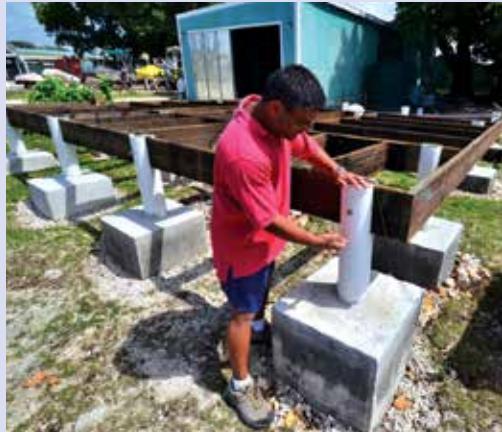
Figure 4-43. Example of steel straps with column base available in Majuro that can be used to connect a concrete spread footing with wood columns. The wood and concrete should not be in contact because the sweating of concrete can cause wood rot. The strap provides separation between the two incompatible materials. An experienced coastal engineer or architect should be consulted to design the footing and columns, if available.

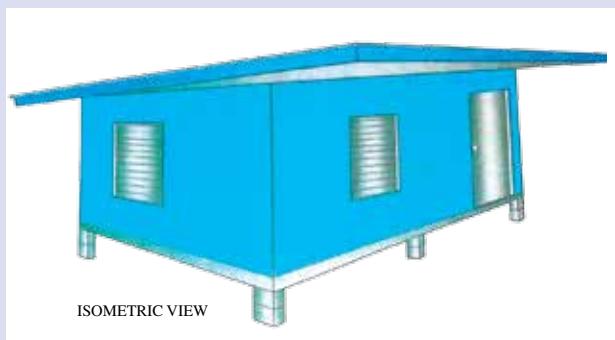
Figure 4-44. Better than treated wood in the ground (Figure 4-38), or a wood column with concrete spread footing (Figures 4-42 and 4-43), is the use of 6 inch PVC pipe extending to the base of the concrete spread footing. The PVC is reinforced with epoxy coated rebar that extends 6 feet below the surface. The rebar is also placed every 6 inches in a horizontal crisscross pattern through holes drilled in the PVC pipe. Concrete is then poured into the PVC. The only wood is 3.5 feet off the ground and is ground contact, termite treated ACZA Douglas Fir (Figure 4-36).

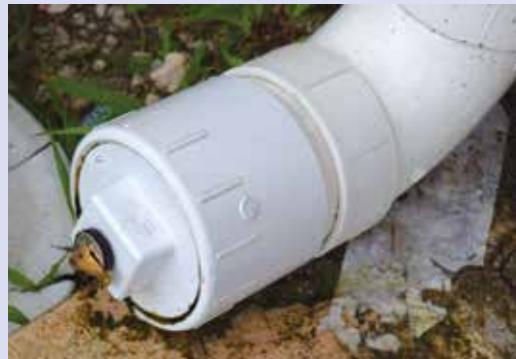
Figure 4-52. First-flush systems help to keep your water catchment system clean and reduce the need for maintenance. Dust, debris, or fecal matter that collects on your roof is washed off when it begins to rain and collects in the diversion pipe to the right. After a sufficient amount of rain has washed the roof, and the diversion pipe is full, either a pipe bend or a floating ball valve diverts water to the left where it is collected in the water tank.

First-Flush System - Combine the leaf screen with a first-flush diverter to help keep dust or microorganisms out of your water tank as rainfall begins (see Figures 4-52, 4-53, and 4-54). This information came from the EPA and also Jina David of the College of the Marshall Islands Land Grant Program.

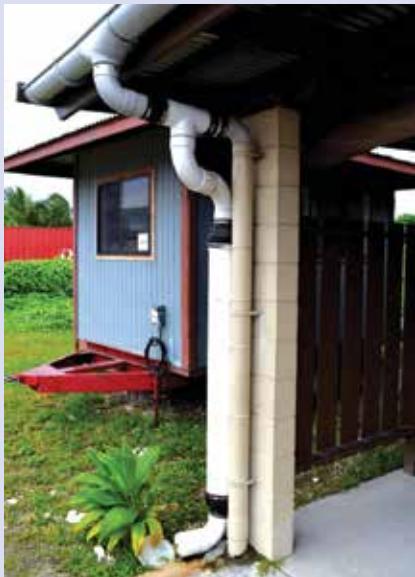
Figure 4-53. At the end of the diversion pipe is a small drain hole that allows the first flush water to slowly drain out so that the diversion pipe is empty for the next rainfall event. In addition, the threaded cap allows for the periodic removal of leaves or other debris.

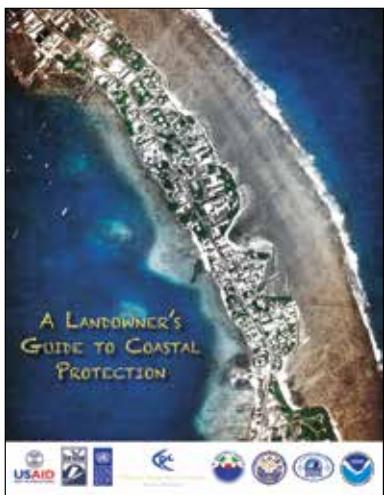
Figure 4-55. From the UH Sea Grant publication “A Landowners Guide to Coastal Protection.” The ocean side of the atoll receives more wave energy and consists of courser grained and steeper ridges or berms. The lagoon side has smaller ridges and finer sediment. It is important to build and maintain migratory and fixed ridges or berms. Also re-vegetate the shoreline below the high water mark with mangroves and above with other suitable salt-resistant varieties.
